SOME GENERALIZATIONS AS TO STRATIGRAPHY IN THROUGH VALLEYS AT THE VALLEY HEADS MORaine IN CENTRAL NEW YORK

by Allan Randall

Landslide Hazards in Glacial Lake Clays - Tully Valley, New York

History of Landslides at the Base of Bare Mountain, Tully Valley, Onondaga County, New York

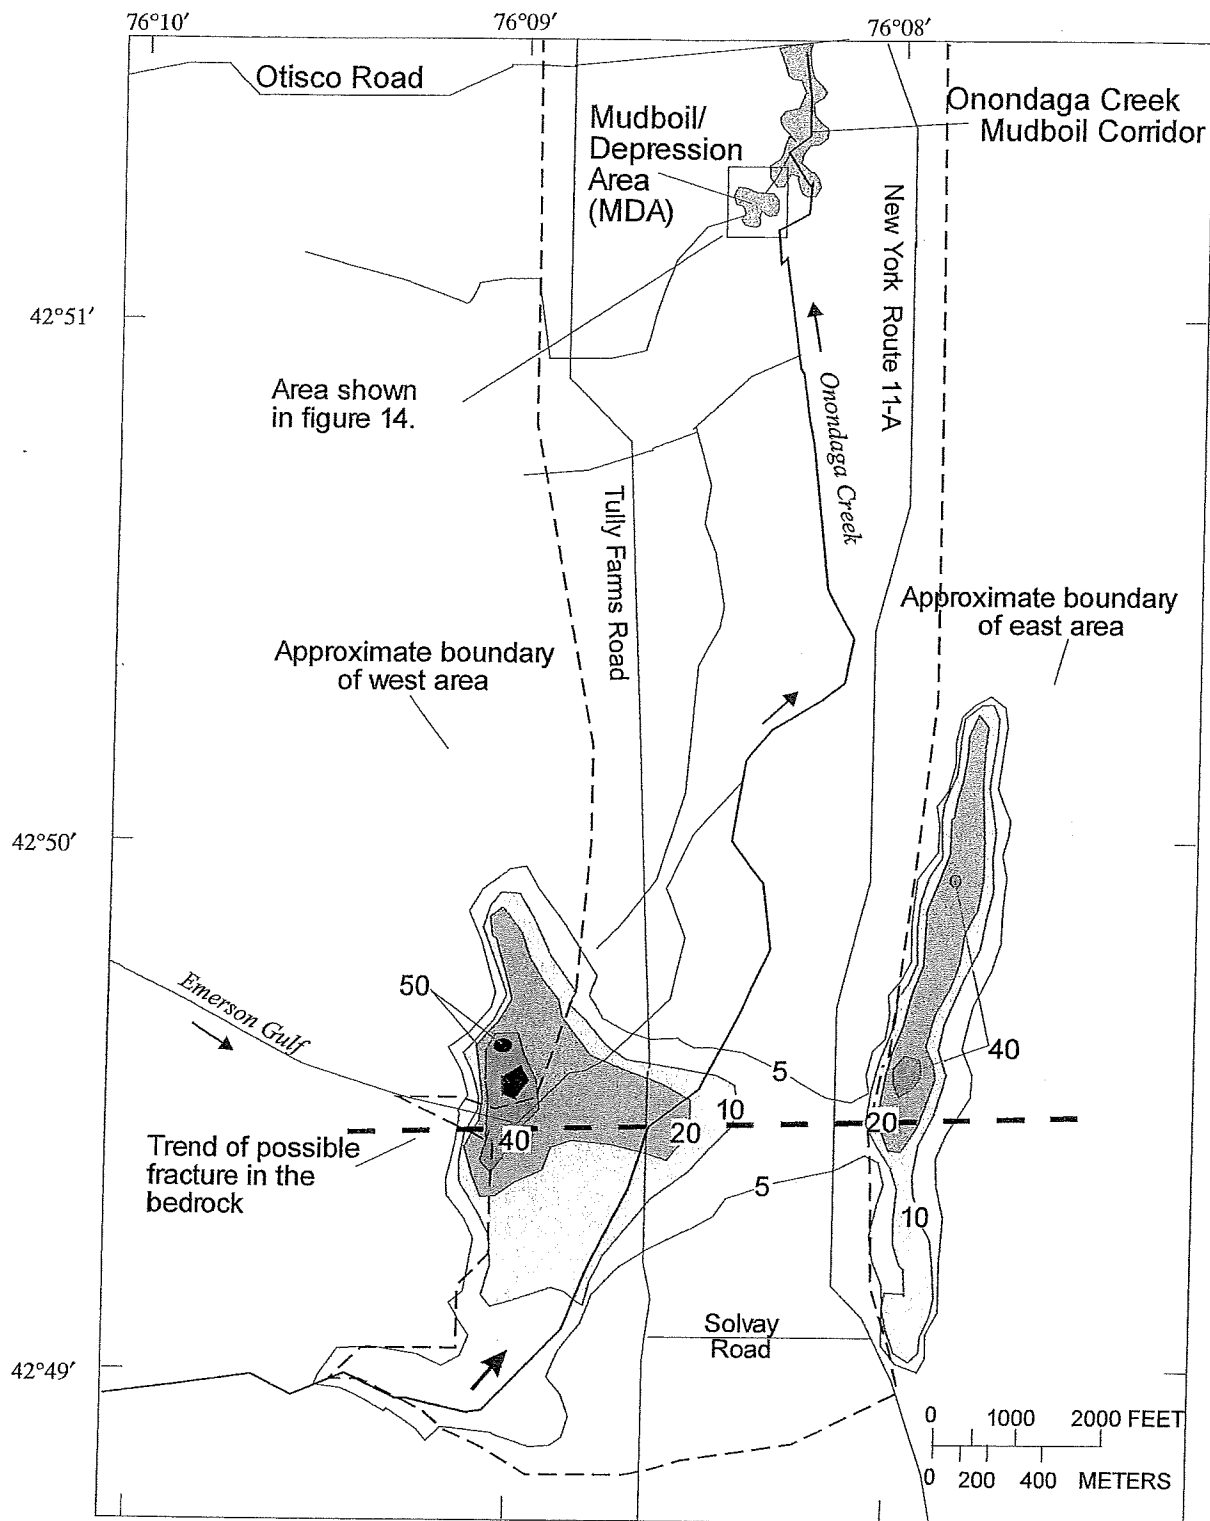
Figure 13. Extent and depth of brinefield subsidence (1957-93) in east and west areas and along a possible bedrock fracture in southern part of Tully Valley. (Modified from Walker and Mahoney, 1993, fig. 7. Location is shown in fig. 2.).

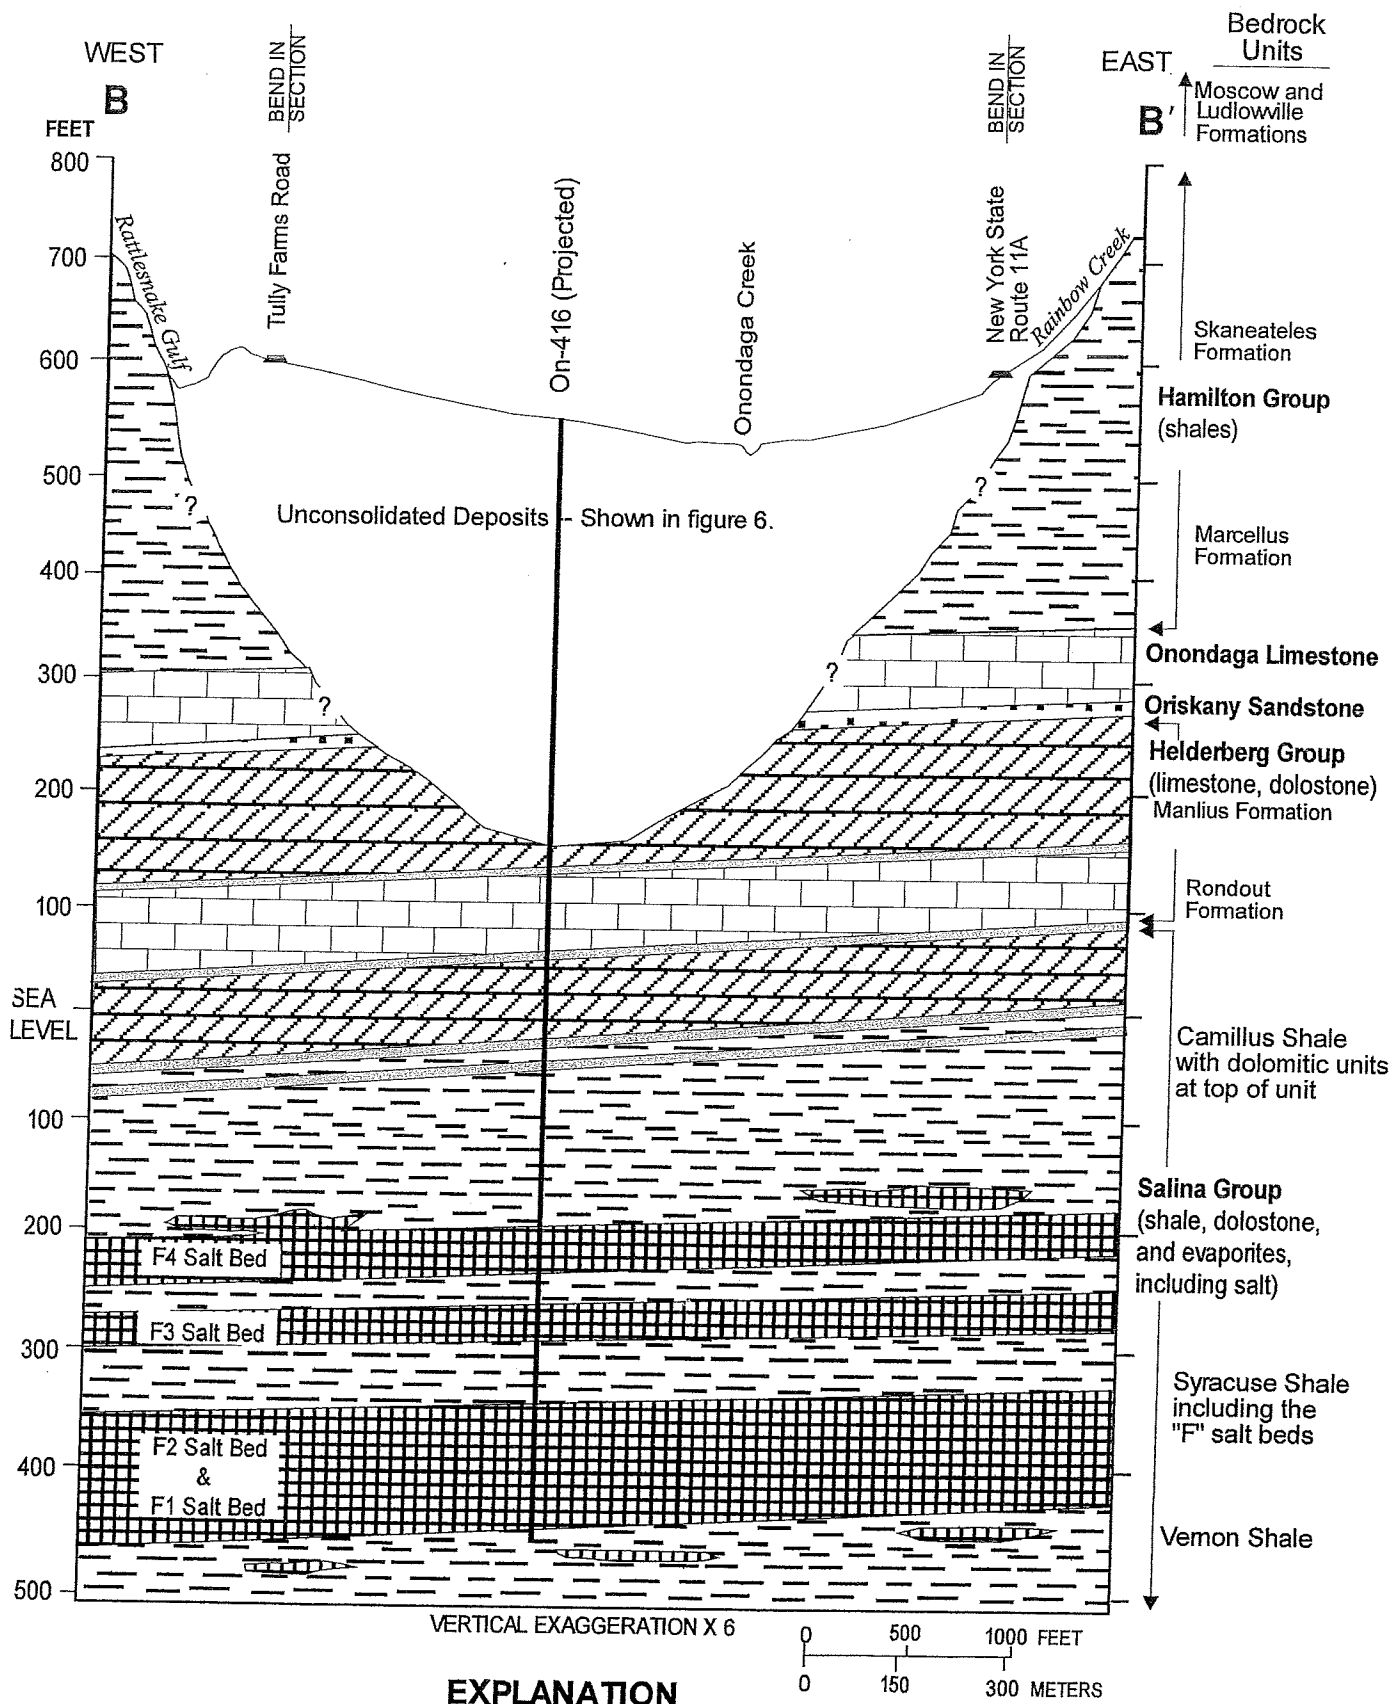
Figure 4. Geologic section B-B' showing major bedrock units below Rattlesnake Gulf and Rainbow Creek from lower valley walls to top of Vernon Shale. (Modified from Getchell, 1982, plate 1. Location of section is shown in fig. 2.)

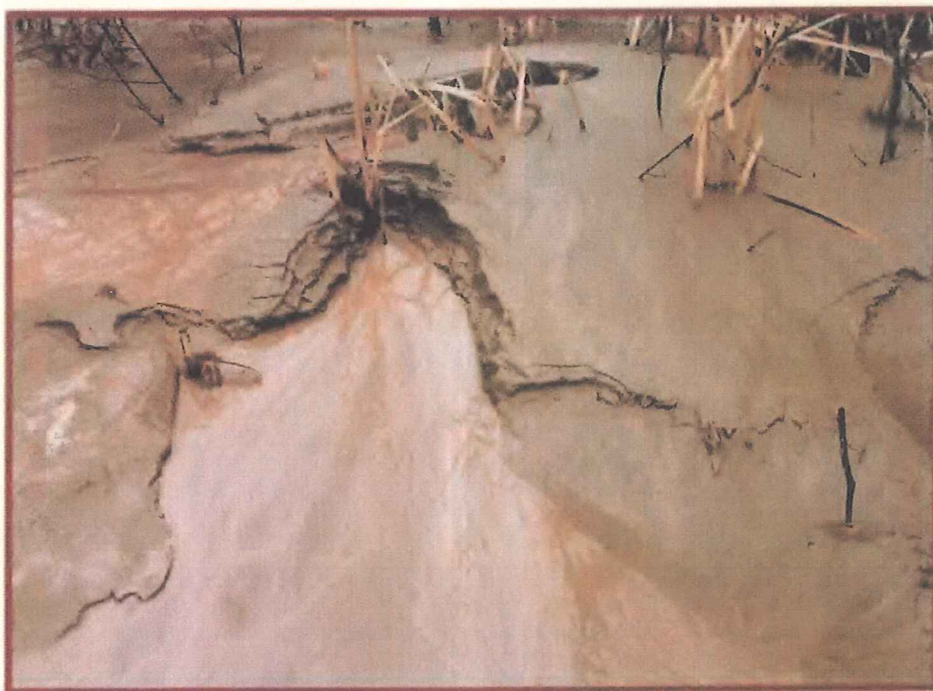
The Tully Valley mudboils are volcanolike cones of fine sand and silt that range from several inches to several feet high and from several inches to more than 30 feet in diameter. Active mudboils are dynamic ebb-and-flow features that can erupt and form a large cone in several days, then cease flowing, or they may discharge continuously for several years.

Mudboils have been observed in the Tully Valley in Onondaga County, in central New York State, since the late 1890's. Mudboils have continuously discharged sediment-laden (turbid) water into nearby Onondaga Creek, which flows to Onondaga Lake. The discharge of sediment causes gradual land-surface subsidence (fig. 1) that, in the past, necessitated rerouting a major petroleum pipeline and a buried telephone cable, and caused two road bridges to collapse. The water discharged from mudboils can be either fresh or brackish (salty).

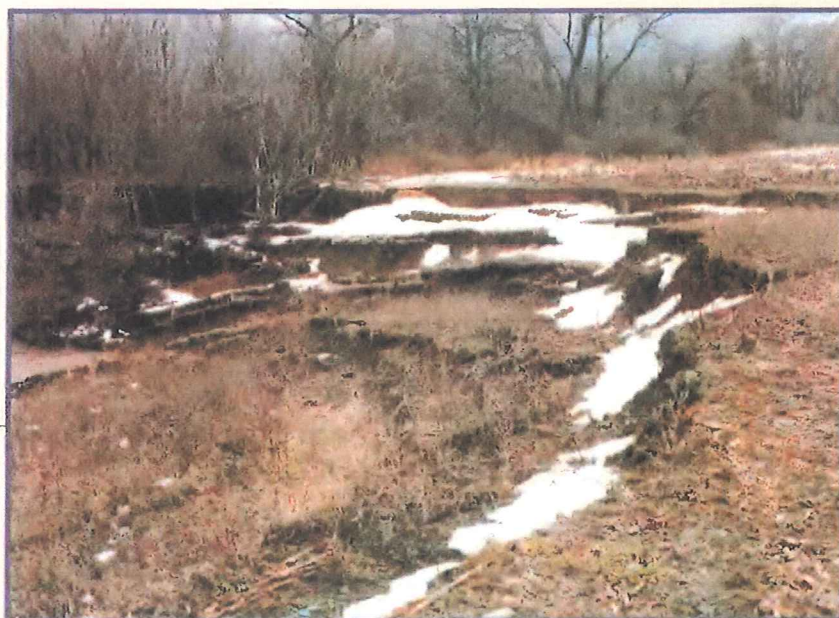
Figure 1. (right) Mudboil/Depression Area, known as the "MDA", as of November, 1994. View of land surface subsidence is toward the west from the MDA dam. (Location shown in fig. 3).

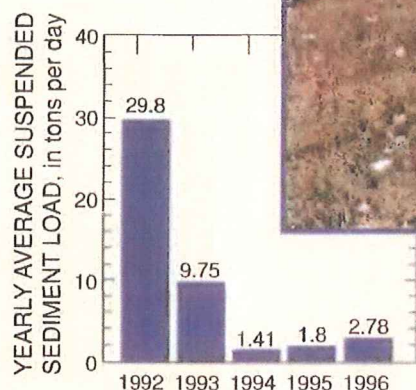
Figure 2. (left) Yearly average suspended-sediment load discharged to Onondaga Creek from the mudboil/depression area, water years 1992-96.

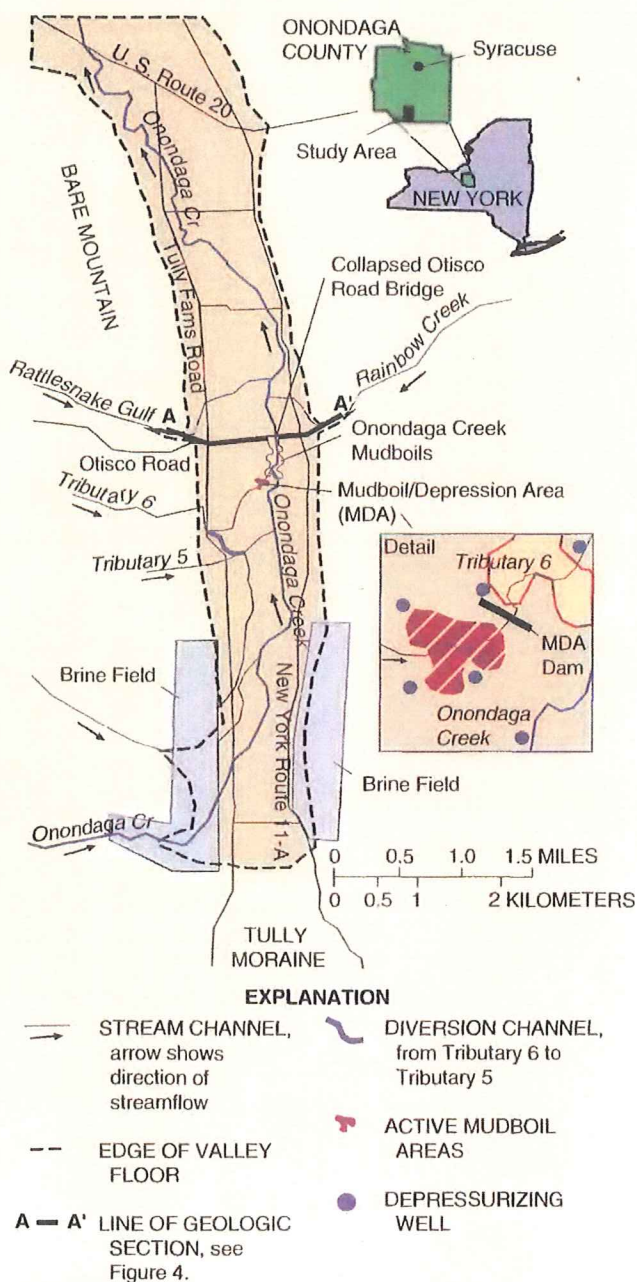
Figure 3. Principal geographic features of Tully Valley, N.Y., and locations of brine field, diversion channel, and mudboil areas. Inset map shows detail of MDA and locations of several depressurizing wells and outlet dam.

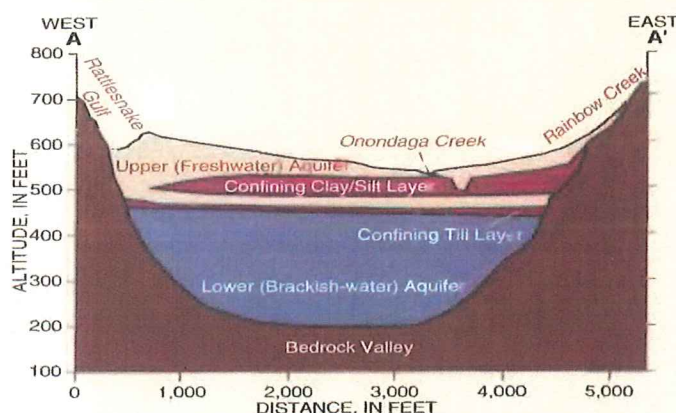
Figure 4. West-east geologic section between Rattlesnake Gulf and Rainbow Creek along Otisco Road, showing upper and lower glacial aquifers and confining clay layers.

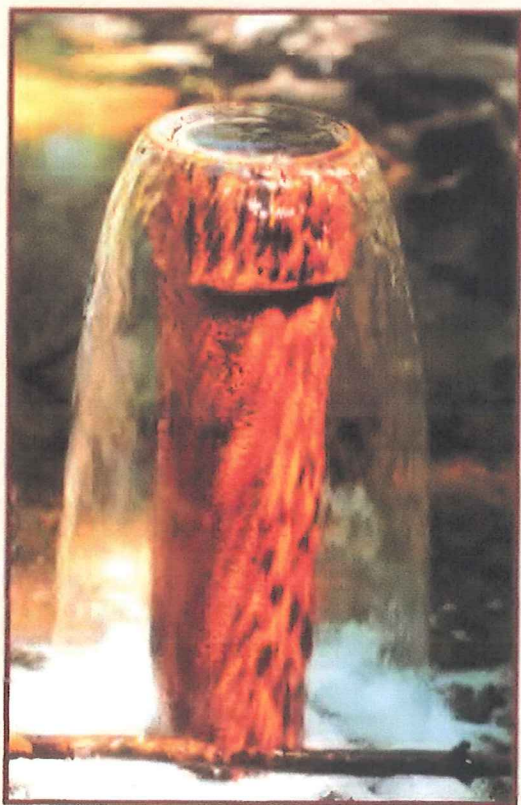
Figure 5. Depressurizing well flowing at a rate of more than 100 gallons per minute near the MDA.

Depressurizing wells were installed near the collapsed Otisco Road bridge during the winter of 1992-93 in an effort to reduce artesian pressures in the upper aquifer and thereby slow nearby mudboil activity. The wells were drilled to the base of the freshwater aquifer, and 10-foot-long well screens were installed to allow artesian-pressured water to flow out of the well while holding the fine-grained sand and silt in place. These wells have a combined discharge of about 25 gallons per minute of sediment-free water and have modestly reduced artesian pressure in the freshwater aquifer by about 1 pound per square inch, or about 2.5 feet of hydraulic head. Nearby mudboil activity did not increase, and no new mudboils have developed since the wells were installed. Furthermore, the discharge of nearby mudboils has been sediment free, indicating possible stability in the area.

Eight additional wells were installed in the aquifers underlying the MDA and Onondaga Creek in the summer of 1996 to further reduce artesian pressure and slow mudboil activity. Total ground-water discharge from all wells averages about 350 gallons per minute. The chemical quality of water discharged from these wells varies with position around the MDA; most of the flows from depressurizing wells screened in the upper aquifer around and downgradient from the MDA are slightly brackish to salty, indicating that water from the lower aquifer is migrating upward into the base of the upper, freshwater aquifer. Water quality upgradient (south) of the MDA, is generally fresh. Discharge from individual wells range from less than 5 gallons per minute to more than 100

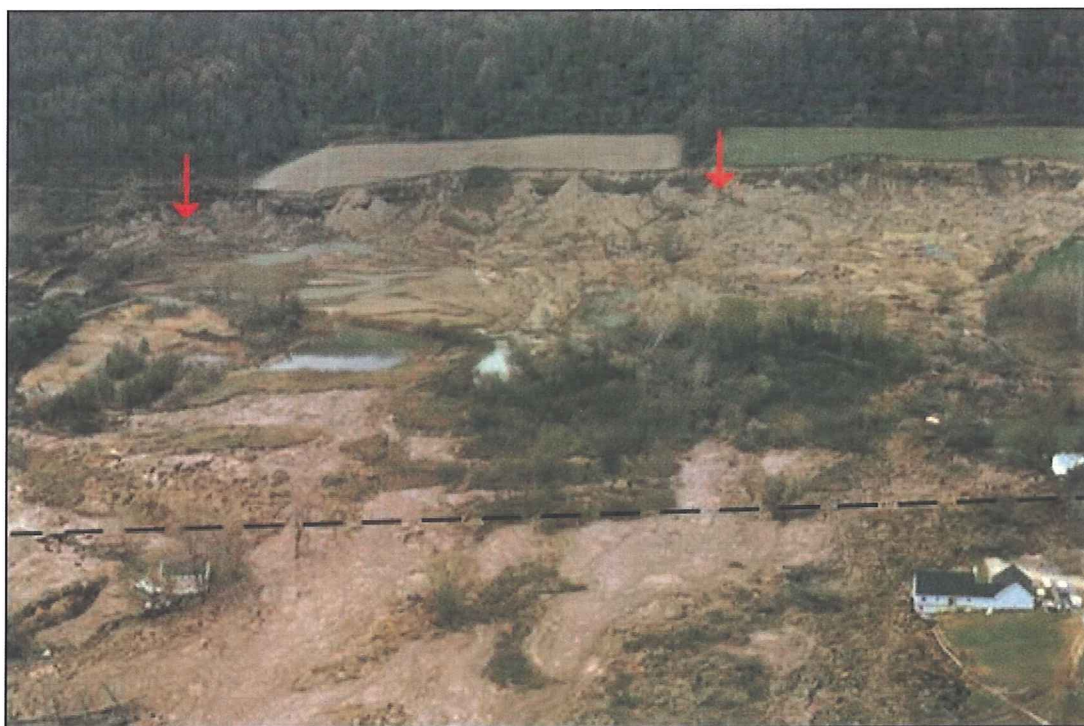
Figure 1. Oblique aerial view of the Tully Valley landslide taken April 30, 1993, 3 days after the slide. Debris moved toward the viewer, in the process covering Tully Farms Road (dashed line) up to 15 feet deep with reddish remolded clay. Three people were rescued by helicopter behind the white house (lower left) from the

rapidly advancing landslide. Springs located between red arrows.

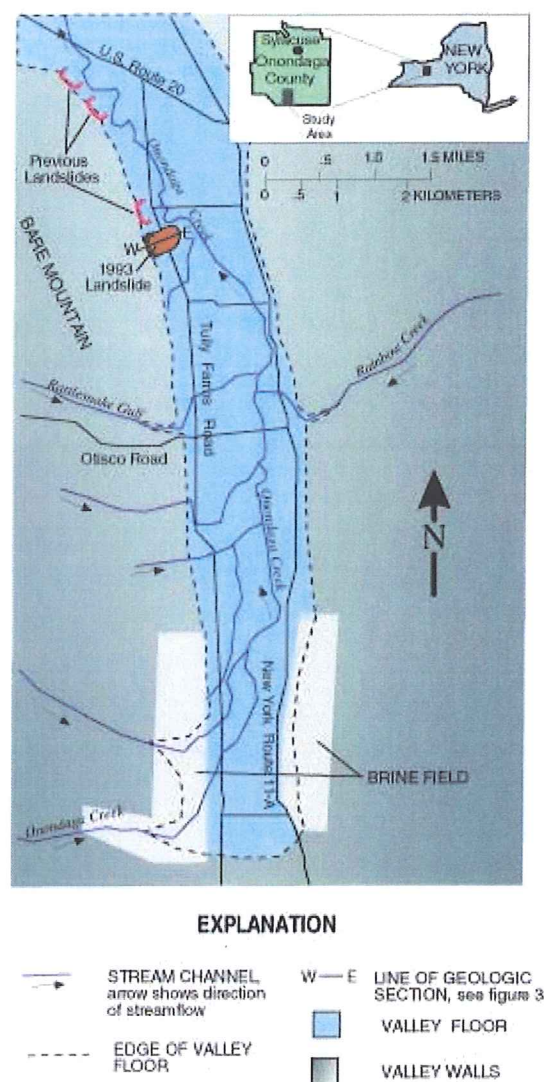
Figure 2. Major physical features in Tully Valley, including the 1993 landslide, previous landslides, and the brine-mining area at the southern end of the valley.

Along the west side of the valley, several older landslide areas have been identified (fig. 2). However, none of the previous landslides were known to local residents or were reported in newspapers or historical records dating back to about 1780. Therefore, the frequency of landslide events in Tully Valley has not been established reliably. As the 1993 landslide has shown, though, the potential damage from such an event can be catastrophic.

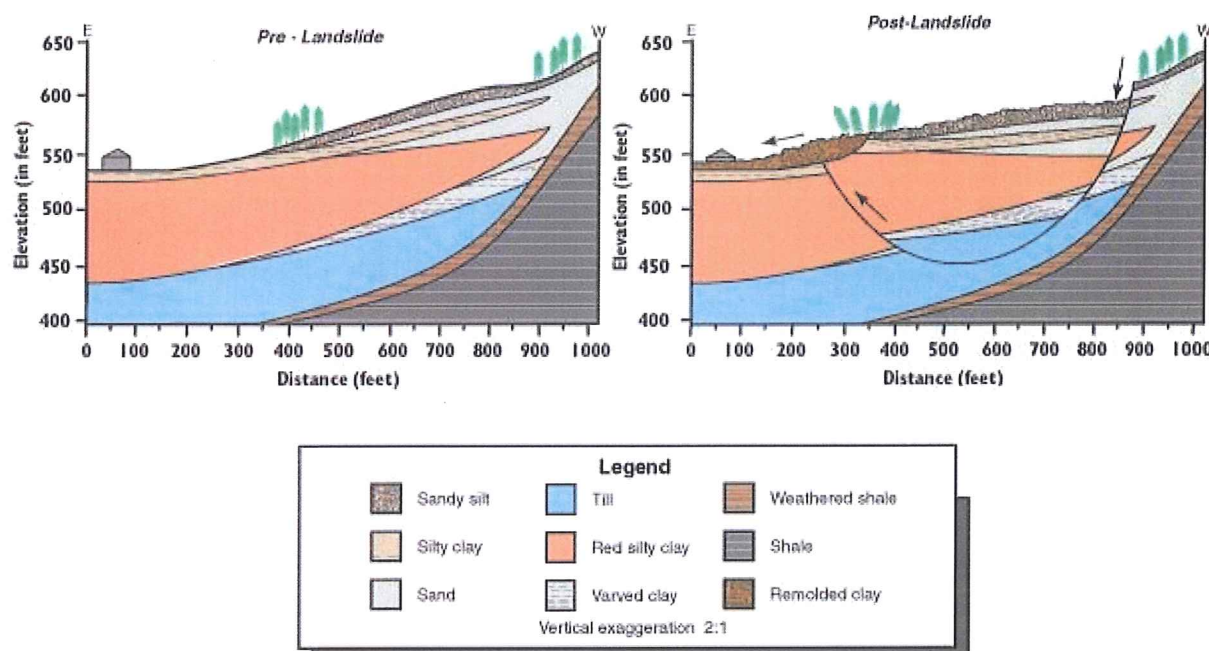
Figure 3. Soil stratigraphy before and after the 1993 landslide.

Profiles of soil stratigraphy before and after the 1993 landslide are shown in figure 3. A massive, red, soft to firm lacustrine silty clay deposit interfingers with coarse sandy soils and a varved clay sequence (fig. 4) that lies against the steeply dipping weathered shale bedrock. The upper thin cover of stiff silty clay traps artesian-pressured ground water in the coarse sand interfingers. Below the massive red clay and the coarse interfingers, a dense till confines and separates brackish water from the overlying freshwater in the coarse interfingers. A few local wells derive domestic water supply from this lower aquifer; however, the water quality has gradually degraded to a point where some wells were abandoned in the late 1980's.

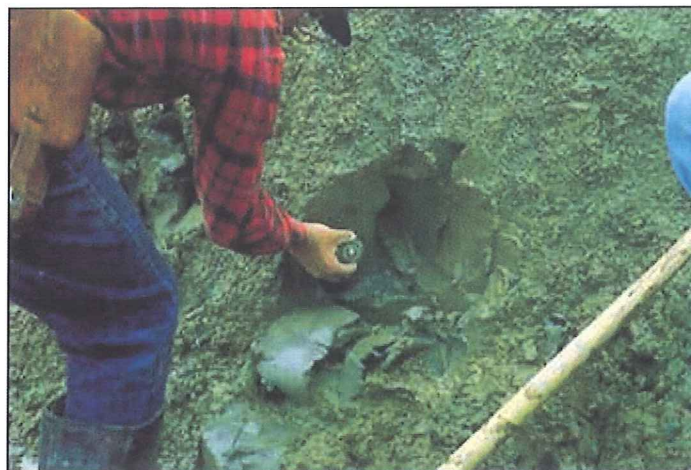
Figure 4. USGS and Syracuse University scientists using a vane shear device to measure undrained shear strength of an exposed stratum of glacial lake clay at the top of the 1993 Tully Valley landslide.

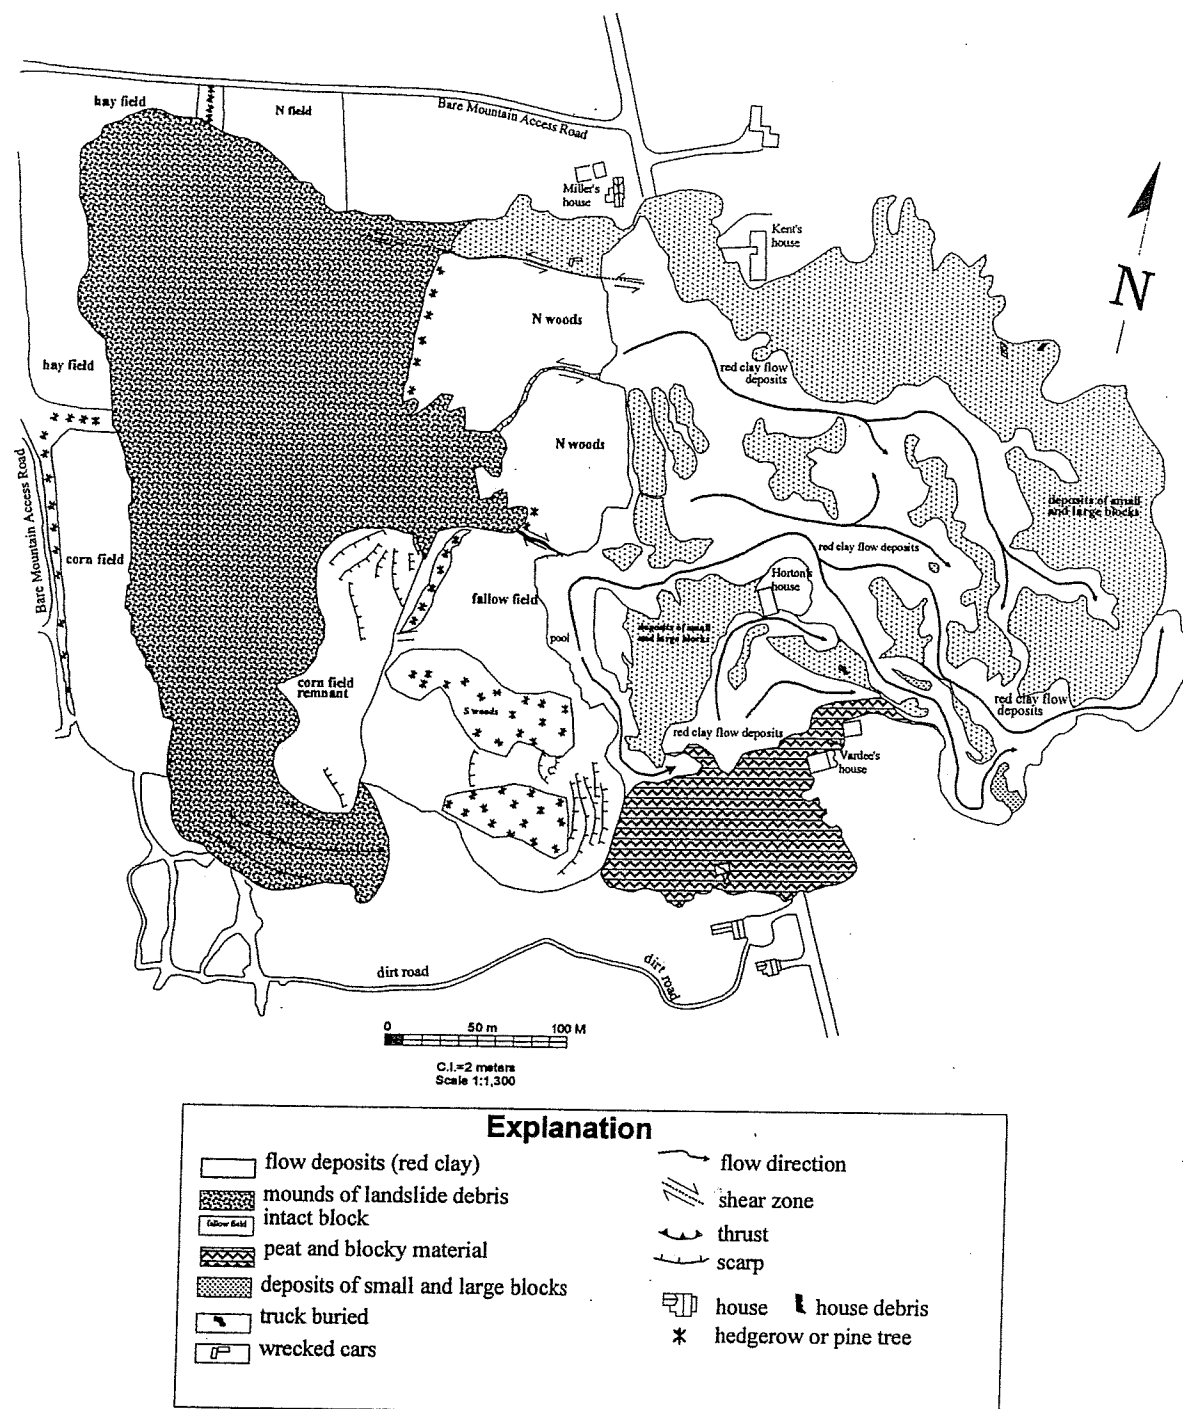
Figure 4.1 Photogeologic map of the Tully Valley flowslide, showing the direction of the flow channels through which the red mud flowed over the blocky flow unit, traced by means of a photogrammetry analysis, from source area (west of the road) up to the flow lobe (east of the road).

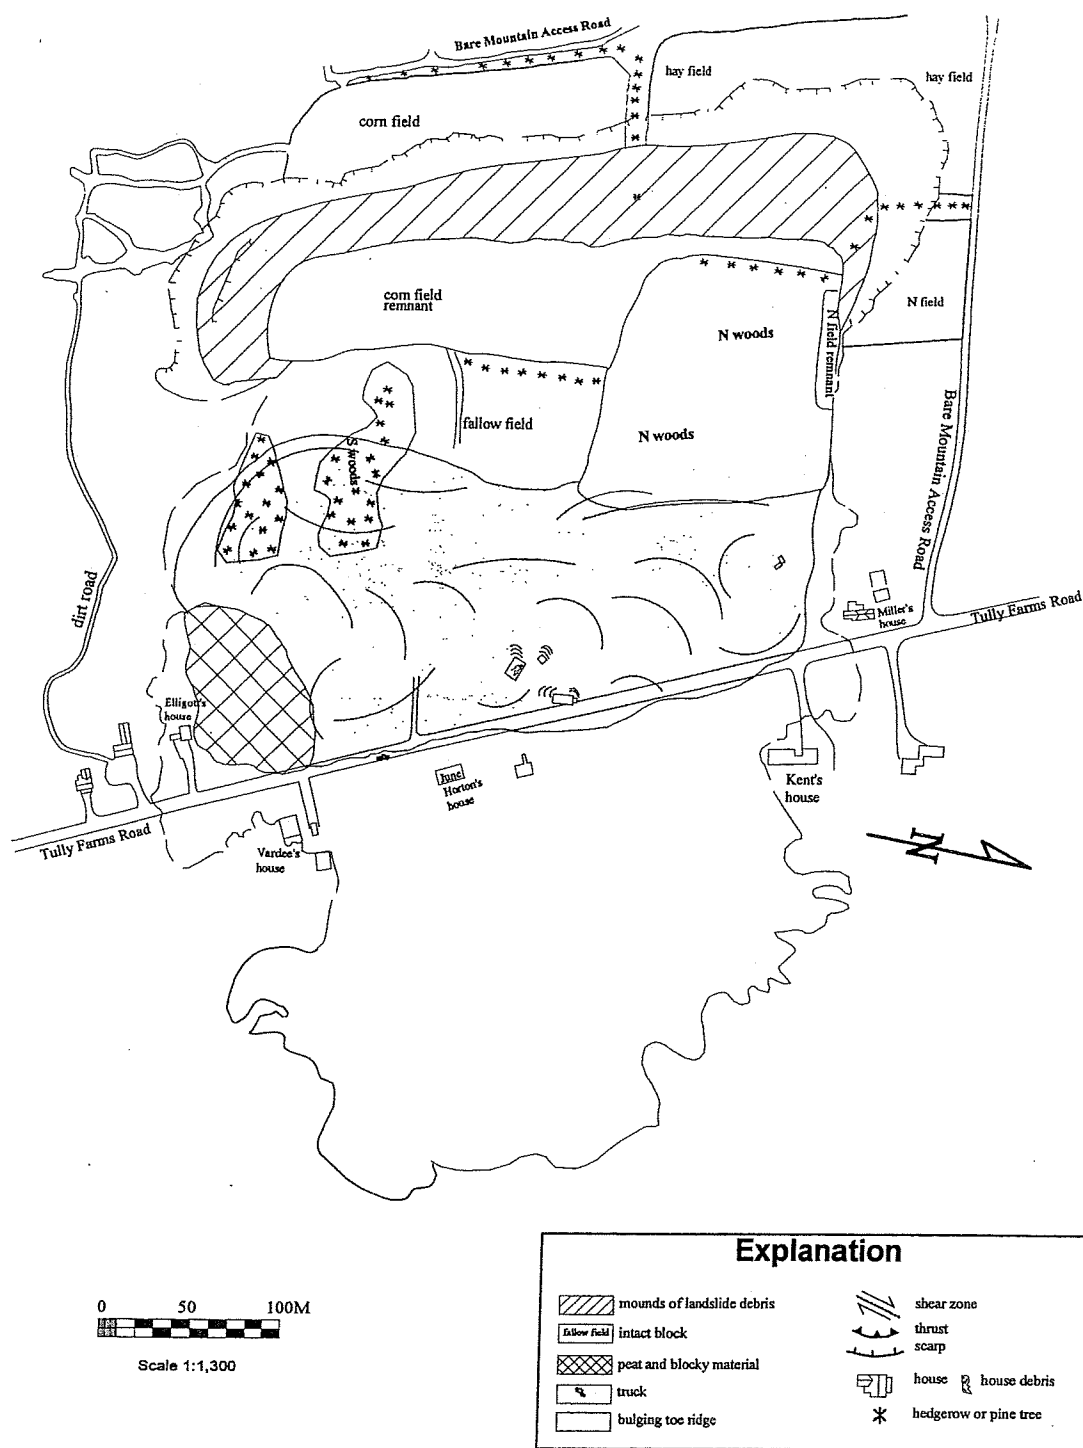
Figure 4.4 Stage I of the Tully Valley Flowslide (initial failure and bulging of toe ridge). The final boundaries of the flowslide are marked as a dashed line for both Stages I and II.

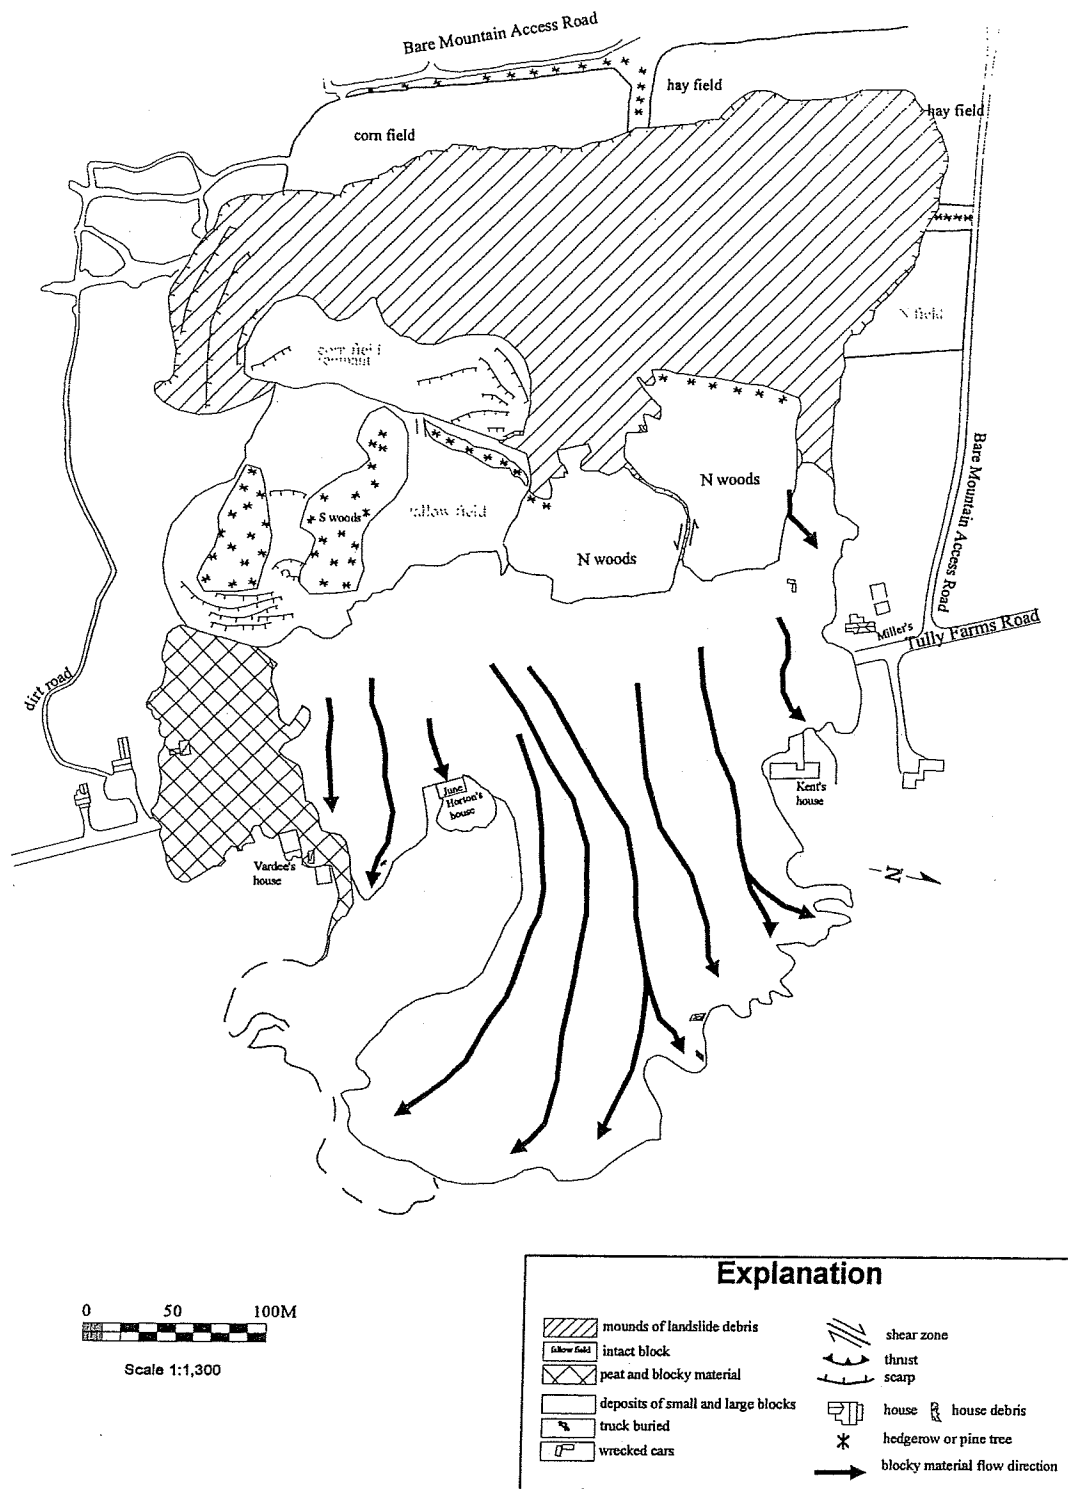
Figure 4.5 Stage II (blocky flow unit deposition) of the 1993 Tully Valley Flowslide.

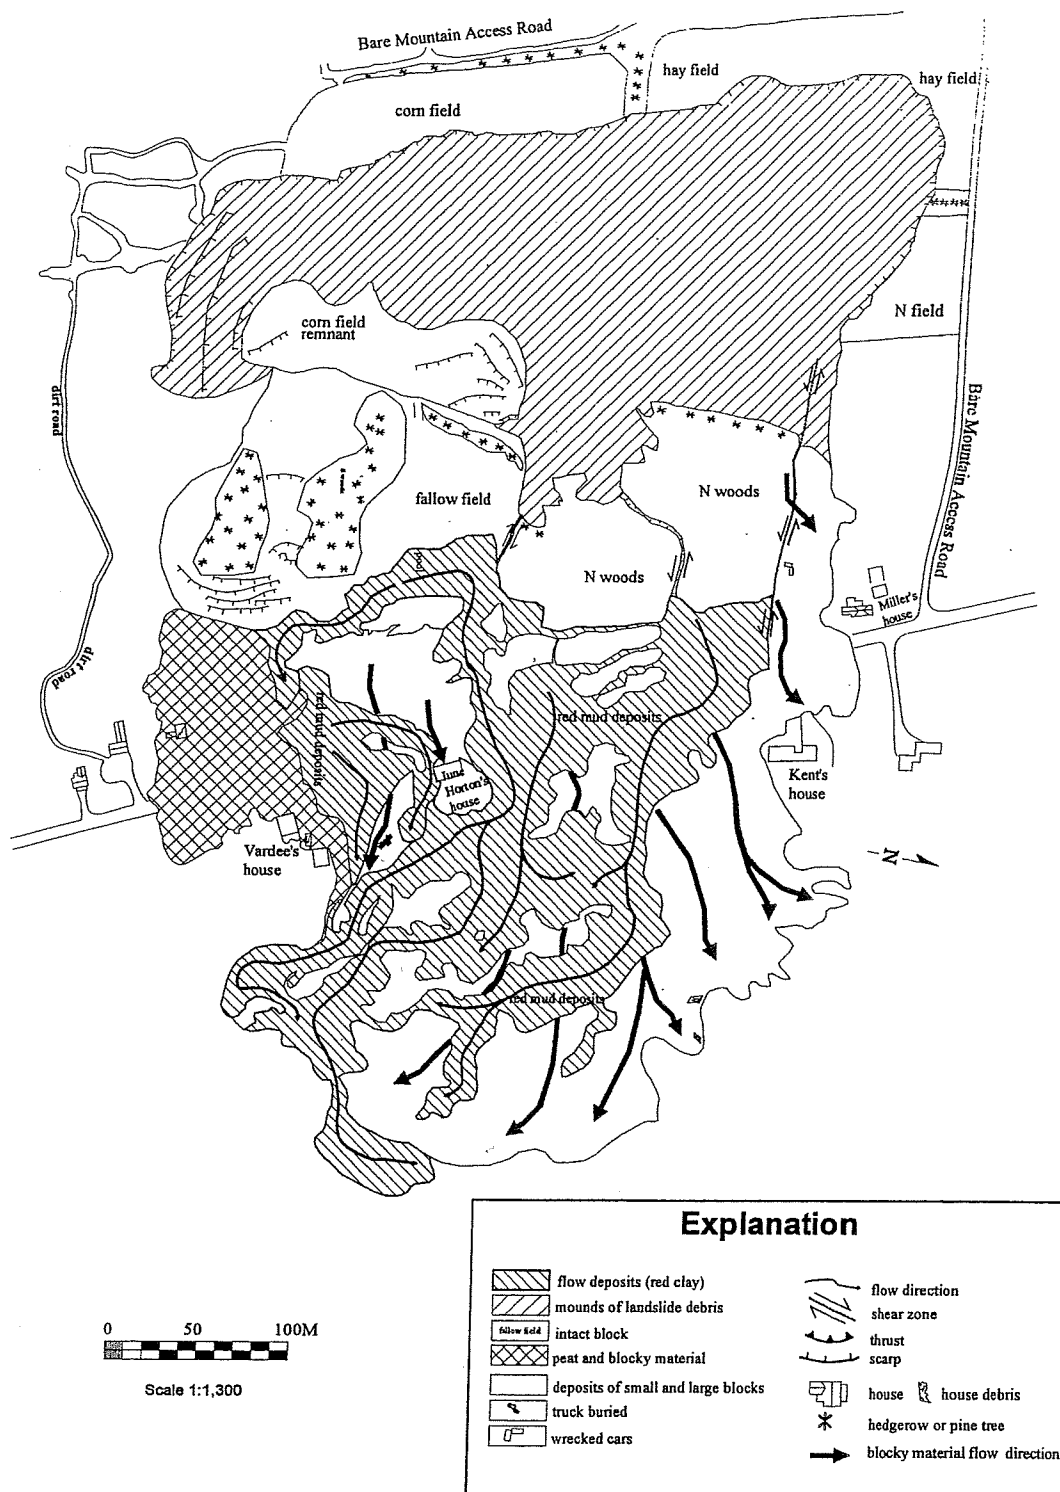
Figure 4.6 Stage III for the 1993 Tully Valley Flowslide (red mud extrusion and flow).

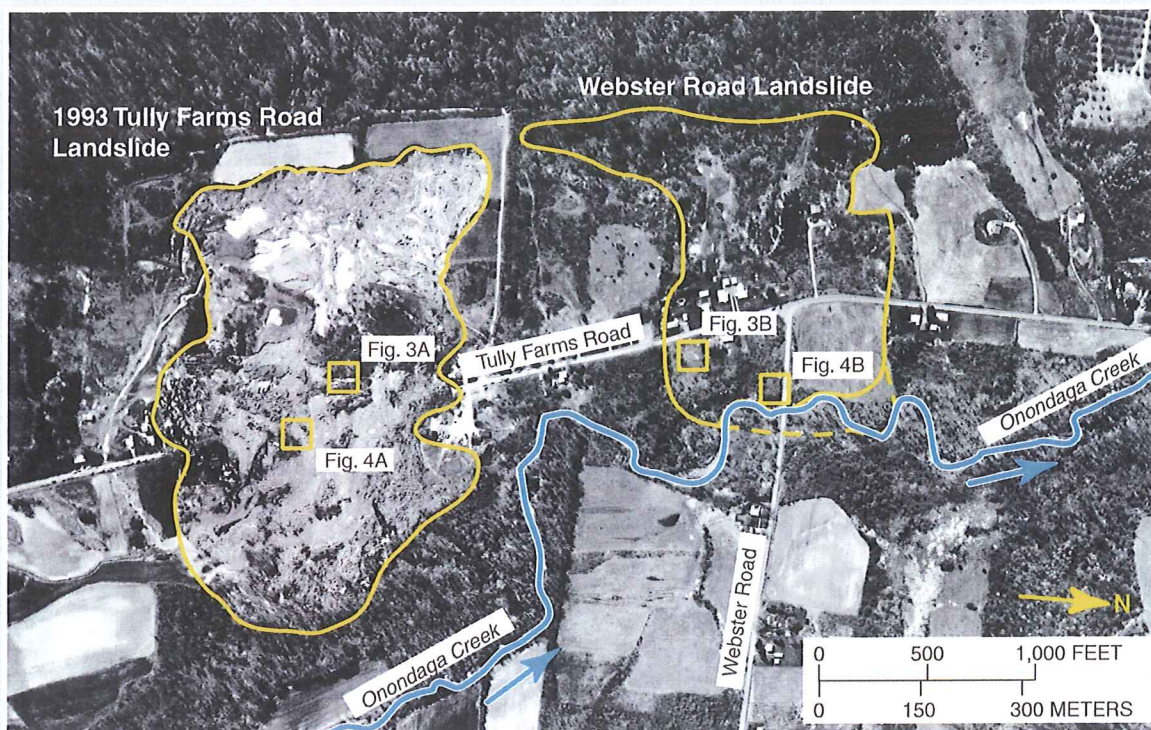
Figure 1. Aerial view of the Tully Farms Road landslide taken May 1, 1993, 4 days after the slide occurred and the approximate location of the Webster landslide, just to the north. Dashed line indicate probable extent of the Webster Road landslide beyond Onondaga Creek, and boxes indicate location of pictures shown in figures 3 and 4.

On April 27, 1993 a large landslide occurred along the foot of Bare Mountain in the Town of LaFayette (fig.1), about 12 miles south of Syracuse. This was the largest landslide to occur in the State since the early 1900's, according to the New York State Geological Survey. Debris from the landslide covered 1,500 feet of Tully Farms Road with more than 15 feet of mud and three homes were destroyed. Most residents were away from their homes at the time, and no fatalities or serious injuries were reported.

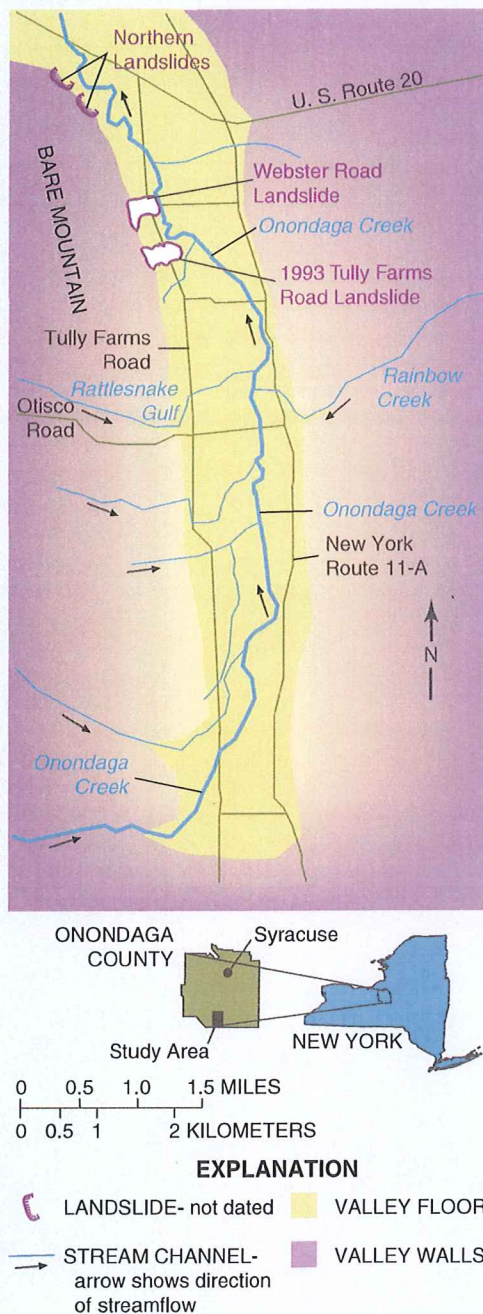
Figure 2. Physical features in the Tully Valley, including the 1993 Tully Farms Road and Webster Road landslides and 2 other landslide areas at the base of Bare Mountain.

Investigation of the 1993 Tully Farms Road landslide revealed an old, inactive landslide area less than 300 feet north of the 1993 site, and upon further investigation along the foot of Bare Mountain, evidence of two more landslides was found about 1.5 miles north of the 1993 site (fig. 2). Jäger and Wiczorek (1994) investigated possible landslide evidence in five valleys near or adjacent to Tully Valley and constructed a landslide-susceptibility map of a small part of southern Onondaga County. The map (scale 1:50,000) was based on results of their landslide-susceptibility model that used the distribution of glacial clays, the extent of former glacial lakes, and slope steepness as variables. The map classifies the region into areas of low, moderate, and high landslide susceptibility. That study identified the Webster Road landslide described below, as well as several other landslide and earth-flow features in the Tully Valley.

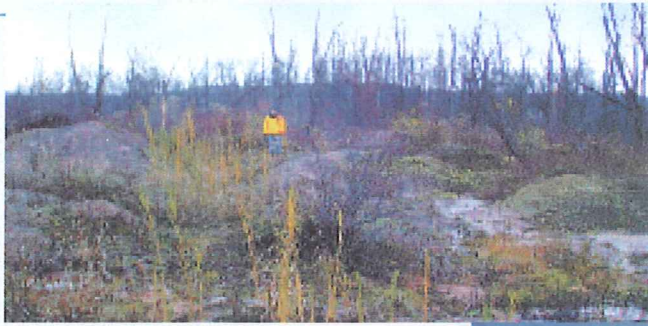
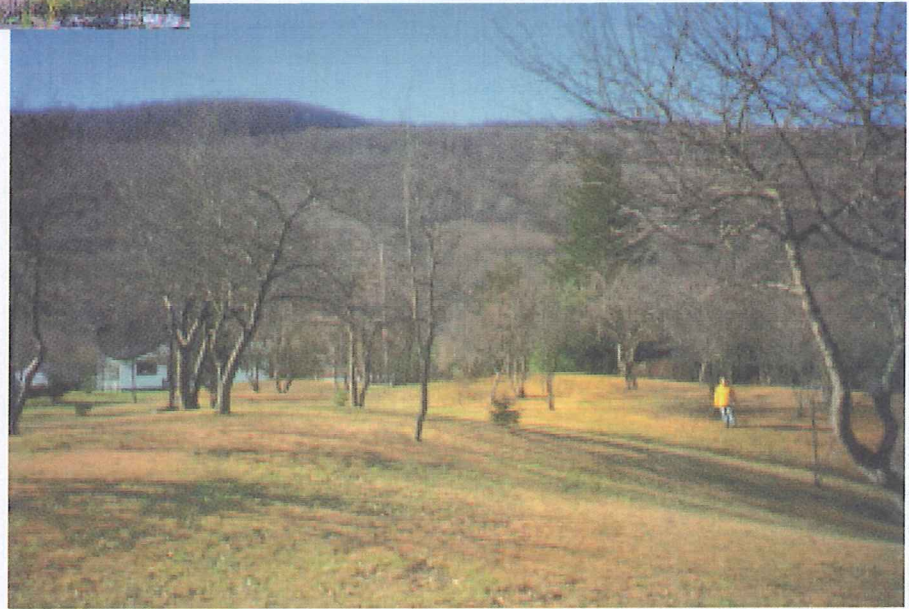
Figure 3. Hummocks found in (A) the 1993 Tully Farms Road landslide area and (B) the Webster Road landslide area (See fig. 1 for locations)

the slope at the Tully Farms Road site and within the toe of the landslide (fig. 3A). These blocks have weathered since 1993, such that the topography now resembles an area of hummocky ground at the toe of the Webster Road landslide (fig. 3B). Thus, the Tully Farms Road and the Webster Road landslide areas are about the same size, and the two landslides seem to have displaced similar volumes of material from the lower slope of Bare Mountain.
