SOME GENERALIZATIONS AS TO STRATIGRAPHY IN THROUGH VALLEYS AT THE VALLEY HEADS MORaine IN CENTRAL NEW YORK

by Allan Randall

Landslide Hazards in Glacial Lake Clays - Tully Valley, New York

History of Landslides at the Base of Bare Mountain, Tully Valley, Onondaga County, New York

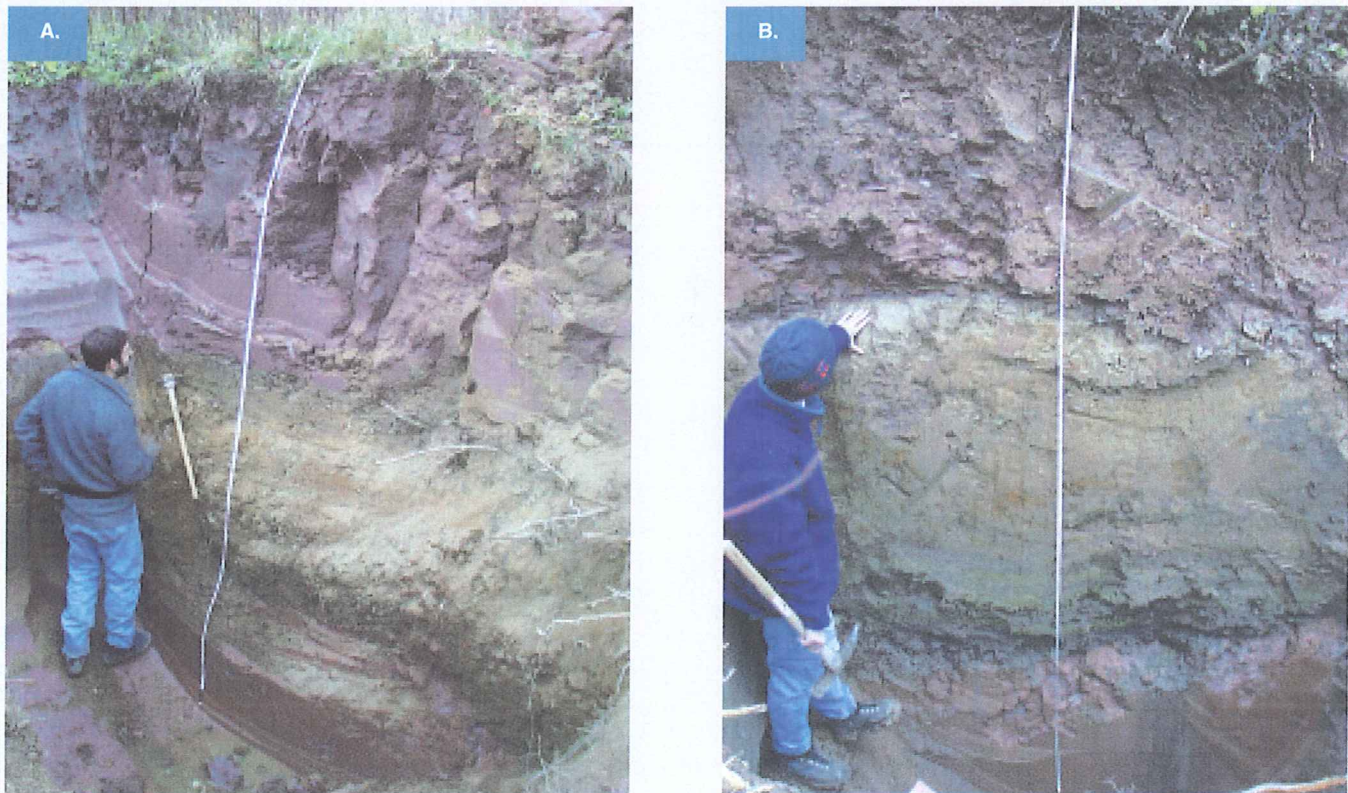
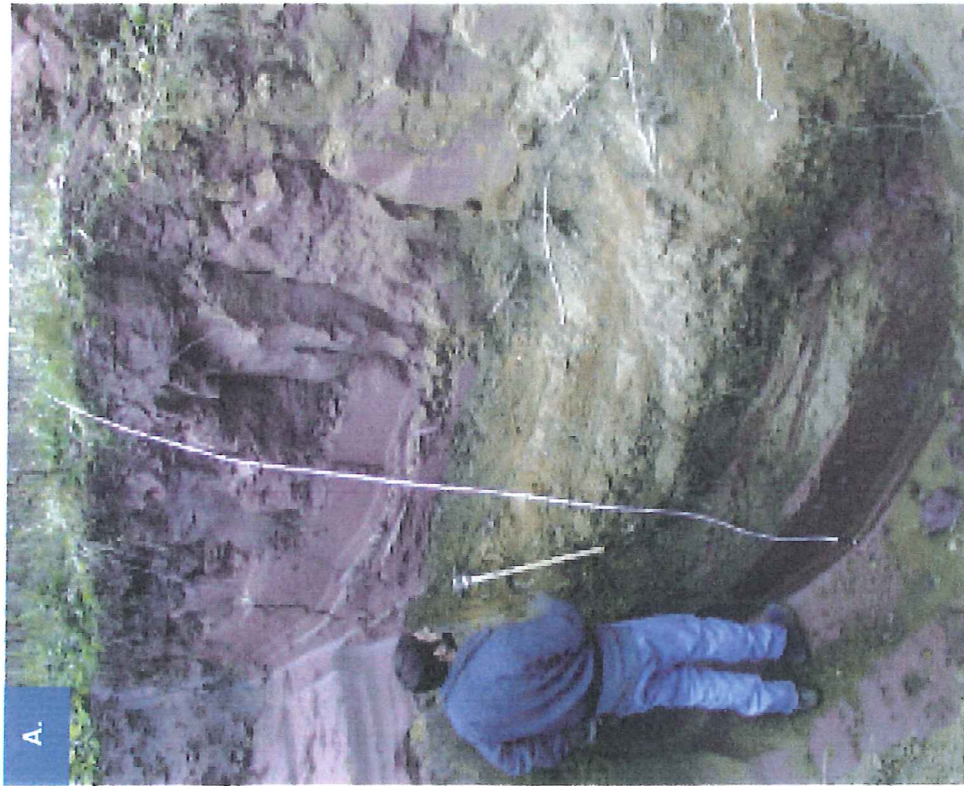
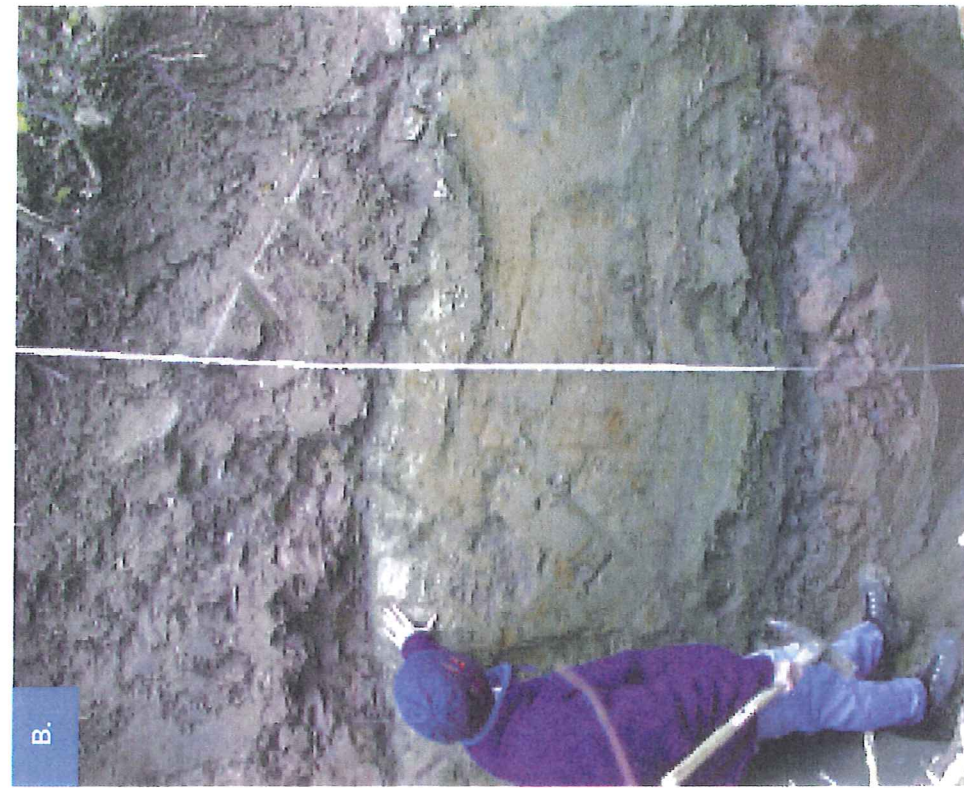
Figure 4. Test pit dug in the 2 landslide areas - (A) the Tully Farms Road pit dug just east of Tully Farms Road, just north of a destroyed home and (B) the Webster Road pit dug on the south side of Webster Road, just west of Onondaga Creek. (See fig. 1 for locations.)

150 feet south of Webster Road, are both within the toe of the Webster Road landslide, and both reveal a stratigraphy similar to that at the Tully Farms Road test pit (fig. 4A). The glacial and postglacial sediments at the Webster Road landslide and streambank sites are overlain by a soil zone with compressed organic matter (primarily grass and small pieces of wood) capped by a massive clay unit that resembles the mudflow material found in the toe of the Tully Farms Road landslide. Two samples of the peatlike organic and woody material found directly beneath the mudflow at the Onondaga Creek streambank site yielded radiocarbon dates of $6,160 \pm 40$ years before present (B.P.), and $6,110 \pm 50$ years B.P. Attempts to find similar buried organic layers at the two northernmost landslide areas (fig. 2) were unsuccessful.

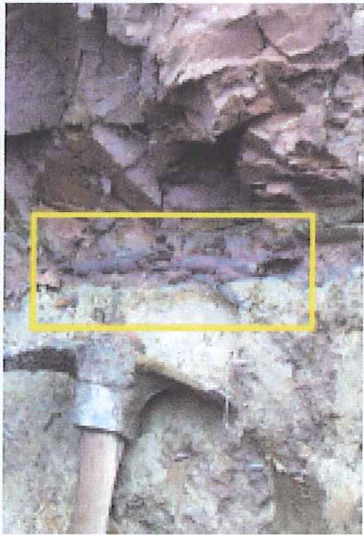
Figure 5. Onondaga Creek streambank exposure south of Webster Road showing the interface between the old land surface and the overlying mudflow materials. Wood fragment (within box) at the interface was dated at 6,160 years before present.

Further investigation of the Onondaga Creek streambank exposed a second organic layer composed of small, ovoid-shaped logs oriented southwest-northeast. These logs were in a gravel unit overlying till several feet below the 6,100-year-old organic horizon. The radiocarbon date of $9,870 \pm 40$ years B.P. obtained for one log suggests that the logs were all of postglacial age. Their parallel orientation and crushed condition indicates that they probably were buried in an older landslide whose magnitude could not be estimated from the sparse exposures along the bank.

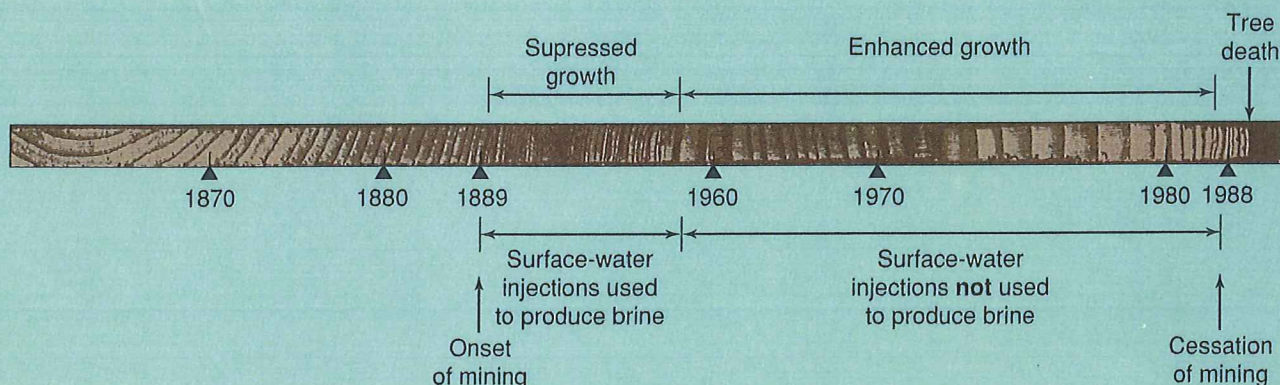
Figure 1. Photograph of core sample (1.5 x life size) removed from the oldest white pine that grew in the wetland. The tree died in late 1995 or early 1996. (Photograph by D. Usher, USGS)

answer these questions by examining the annual growth rings of trees (fig. 1). Each ring can be assigned an exact year of formation, and yearly differences in ring widths can be used to compare past and present conditions on a flood plain, along a river, or within a wetland. Thus, tree rings provide information that otherwise might be difficult or even impossible to obtain.

A twenty year sequence of unusually wide rings began about 1960 or shortly thereafter (fig. 1), indicating that conditions for tree growth improved strikingly and quickly. The onset of this "growth release" in wetland pines coincides with closure of the eastern part of the brine field in 1957 and the

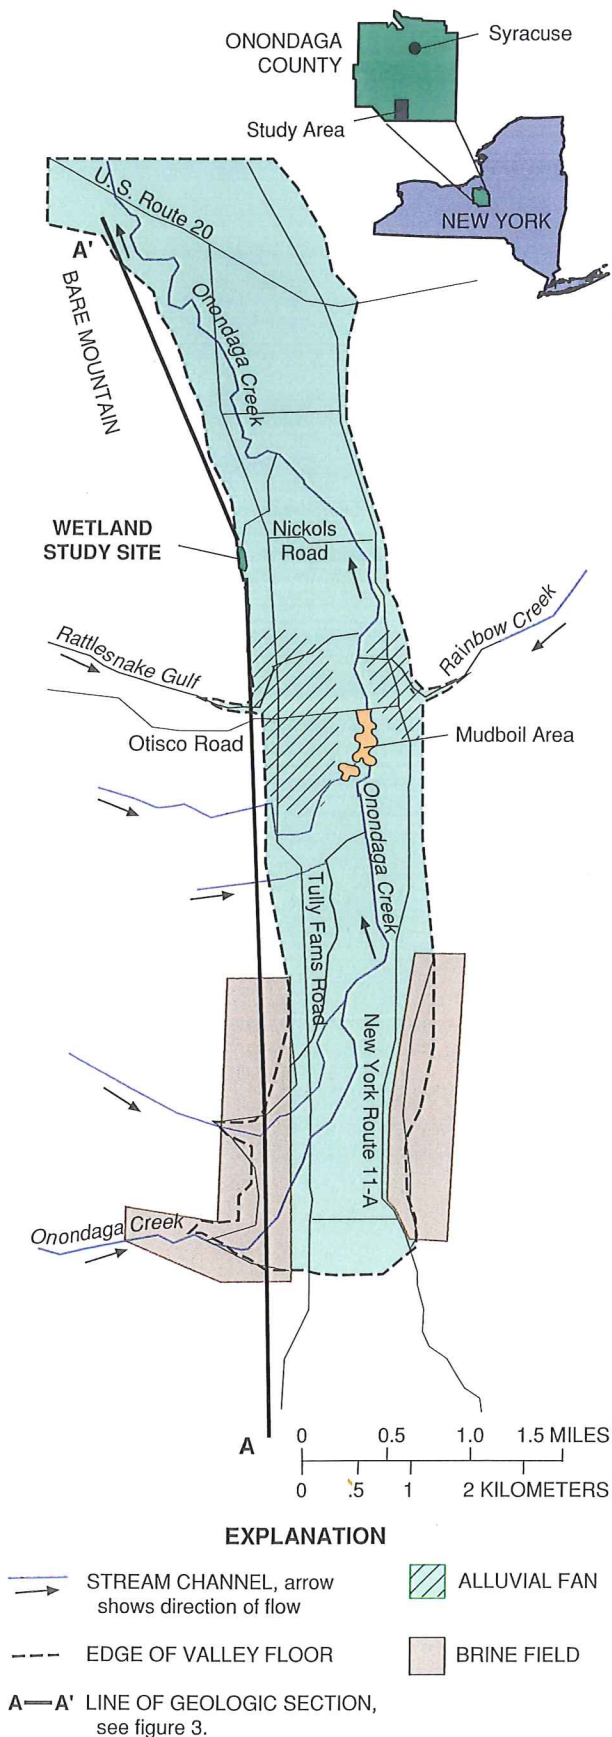
Figure 2. Map of the Tully Valley showing the location of solution-brine fields and study wetland.

The Tully Valley (fig. 2) is within the Finger Lakes Region of the Allegheny Plateau. The small (2 acre) wetland is in the northwestern part of the valley at the base of Bare Mountain. Ground-water flow feeding the wetland is from a series of fresh- and brackish-water springs at the foot of the mountain. Freshwater springs are fed by precipitation infiltrating the hillside slopes, whereas brackish springs are fed from the deep shale-bedrock flow system. Concentrations of sulfate, sodium, and chloride in brackish flows are naturally high because they leach into the groundwater as it moves slowly through fractures in the mineralized bedrock. Flow from the freshwater springs typically is least during summer, increases in fall, remains fairly constant throughout winter, and increases again during the spring in response to rain and snowmelt. Brackish discharge is more uniform than freshwater discharge, although brackish flow generally also is greatest during the spring. Thus, fresh and brackish waters flow into the wetland during the spring, but brackish discharge predominates during summer. Several small drainageways in the wetland form a small stream that carries outflow to the northeast. Flow of this stream is entirely from the fresh- and brackish-water springs at the base of Bare Mountain.

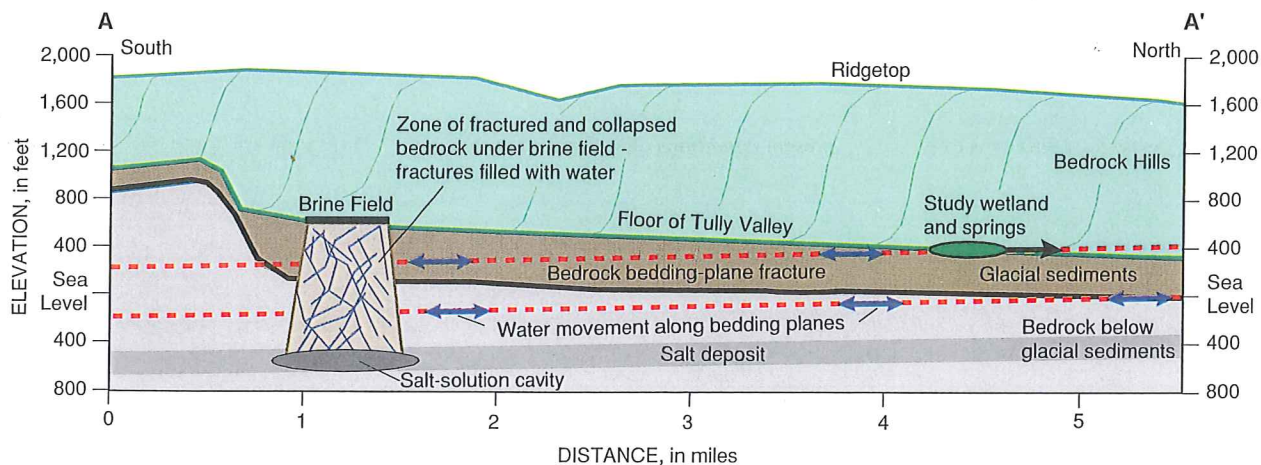
Figure 3. Schematic cross-section of the Tully Valley showing bedrock and bedding-plane fractures that provide a flowpath from the south to the north.

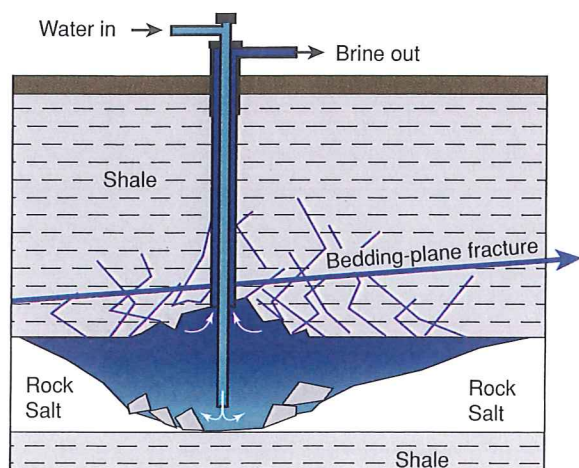
Figure 4. Solution-salt mining

The solution mining of salt in the late 19th century began with drilling a hole down to the salt layer, and the installation of two steel casings into the hole. Fresh water was pumped down the inside casing where the water dissolved the rock salt and produced a brine (salt water). The brine was "lifted" and later pumped up to land surface in the outside casing. As large amounts of rock salt were dissolved, the unsupported shale rock above the salt cavity began to break and fall into the salt cavern. As the cavern became larger, the shale bedrock continued to break and slowly fill the cavern with broken rock, which eventually caused subsidence at land surface. Initially, the subsidence was small and gradual, and generally unnoticed. Later, as the cavities became larger, the land-surface subsidence was greater and more noticeable.
