# Ecological Status of Onondaga Creek in Tully Valley, New York — Summer 1998

# Lakes, Deltas, and Drainage in the Onondaga Valley

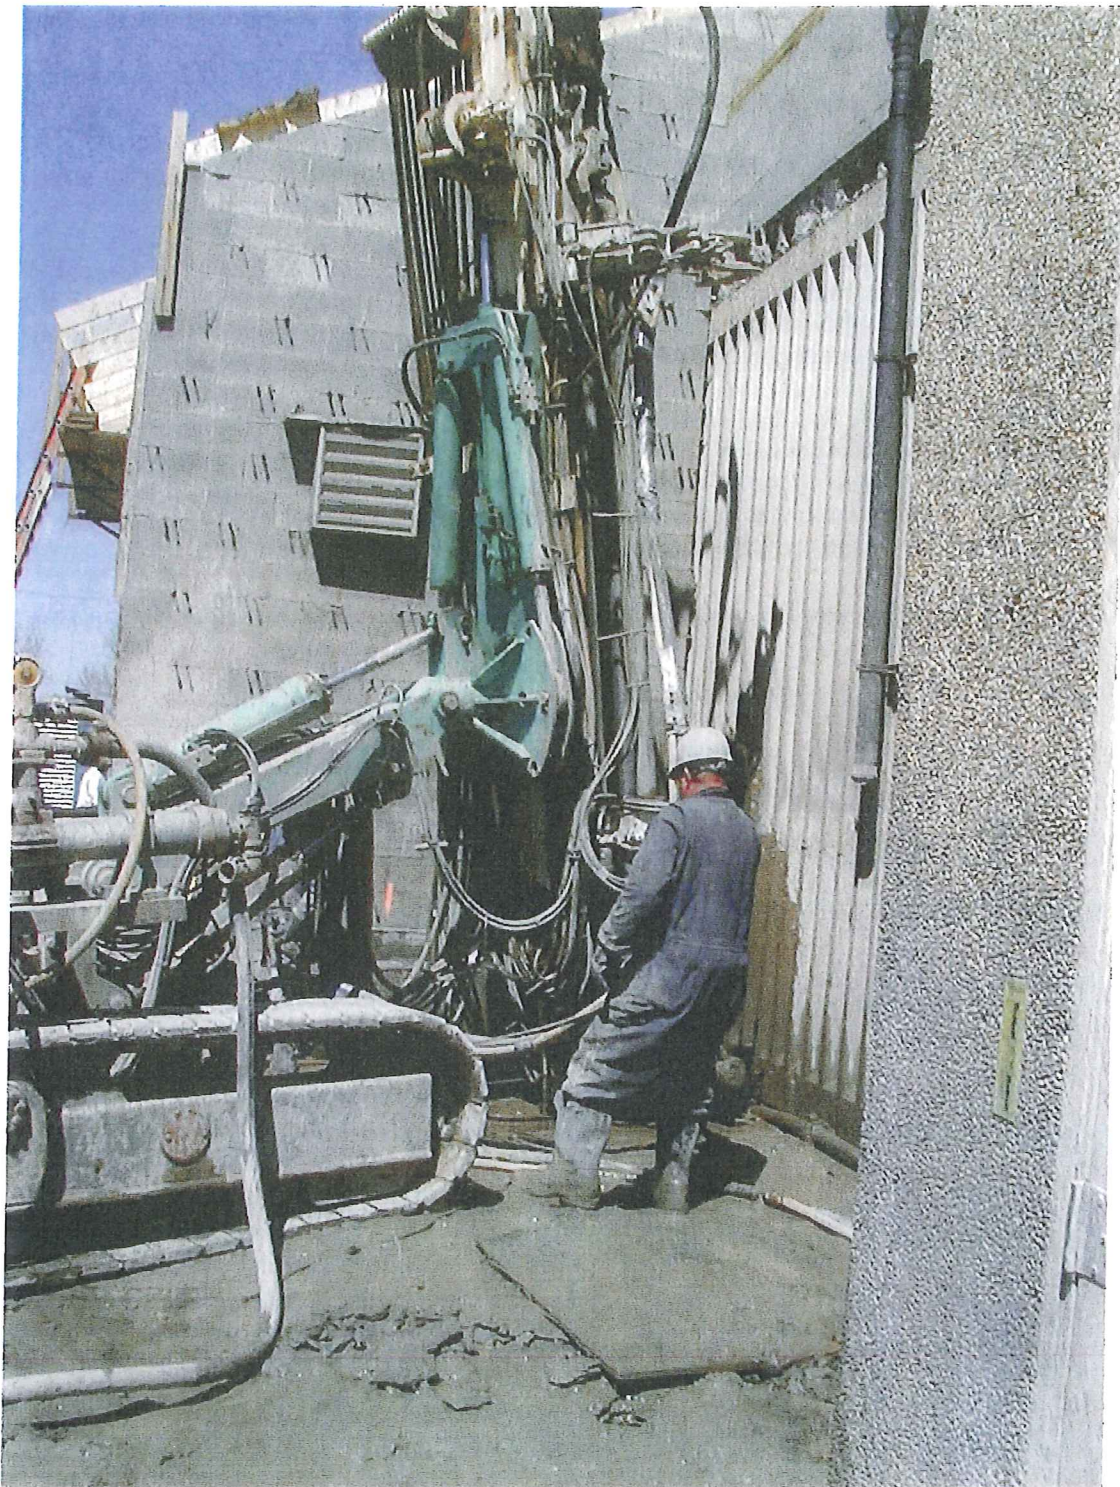
**Figure 9: Installation of jet grout column to underpin screen room**

The existing structure was then underpinned by jet grouting. The building was never undermined by more than 1 fluid column within 15 ft. After the underpinning grout set up overnight, additional columns were installed. Concurrently, jet grout columns were installed to construct the bottom seal. The jet grout column plan was as shown on Figure 8. Figure 9 shows installation of a battered jet grout column for underpinning the screen room.
