In cooperation with Onondaga Lake Cleanup Corporation

Hydrogeology of the Tully Lakes Area in Southern Onondaga and Northern Cortland Counties, New York

By William M. Kappel, Todd S. Miller, and Kari K. Hetcher

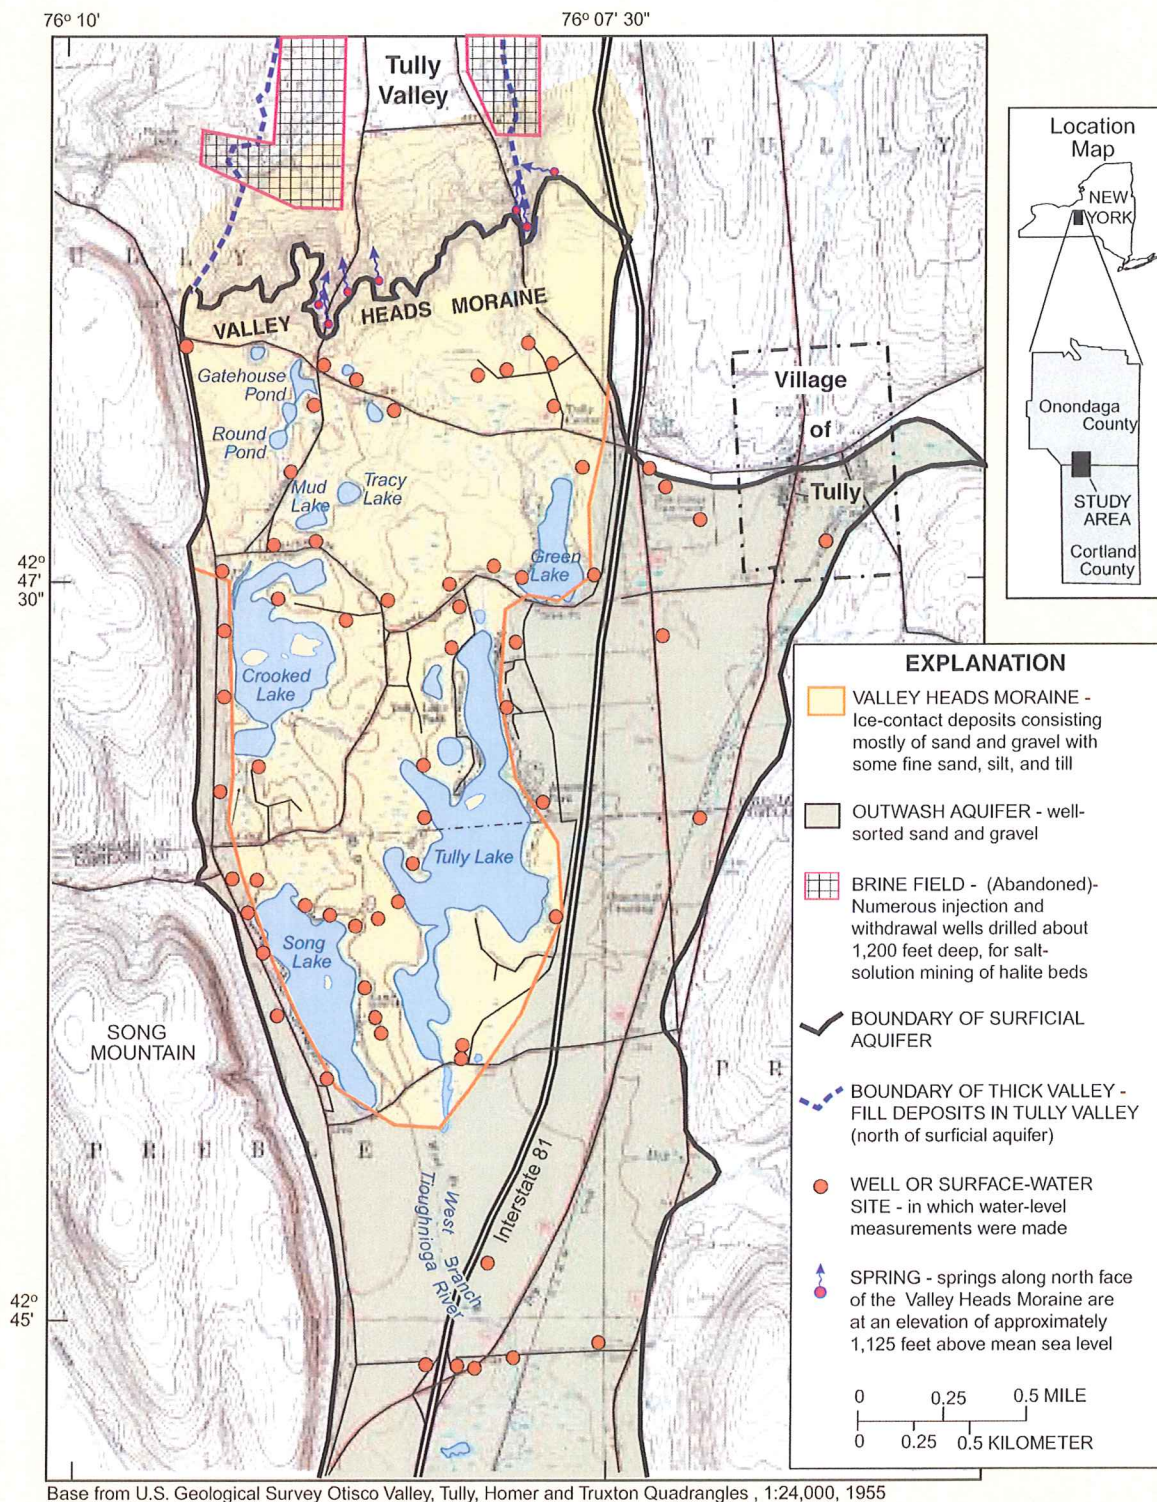
Figure 1. Principal geographic features of Tully Lakes area, including surficial aquifer, Valley Heads Moraine, Tully Valley brinefield, and locations of wells and water bodies used for water-level measurements.

The topography of central New York, and the associated hydrologic systems are the result of the advance and retreat of glaciers during the last (Wisconsinan) glaciation. A pause in the retreat of the glacial ice led to the formation of the Valley Heads Moraine near the village of Tully (fig. 1). This moraine, which consists mostly of sand and gravel with some till, trends east-west across the southern end of Tully Valley and forms the surface-water drainage divide between the St. Lawrence and Susquehanna River Basins.

The Tully Lakes area (fig. 1) encompasses a 3-square-mile area within the moraine and is characterized by gentle rolling hills, and kettlehole lakes and ponds. The coarse-grained moraine deposits and glacial outwash that extend south of the moraine form a large unconfined surficial aquifer, from the West Branch Tioughnioga River to the village of Tully. The area contains six kettlehole lakes (Green, Tully, Crooked, Song, Tracy, and Mud), several kettlehole ponds (Gatehouse, Round, and a few unnamed ponds), and several seasonally wet to permanently dry kettleholes. All of the western lakes and ponds (Song, Crooked, Mud, and Tracy Lakes, and Round and Gatehouse Ponds) were naturally landlocked, with no perennial inlet or outlet, until European settlement in the early 1800's. By the mid-1800's, outlet pipes or channels had been installed in Gatehouse Pond and Crooked, Mud, and Tracy Lakes to allow use of their water by several industries over the next 120 years. The two eastern lakes (Green and Tully), in contrast, have natural outlets at their southern ends. Green Lake drains through a short channel into the northern end of Tully Lake. The West Branch Tioughnioga River enters Tully Lake on its southeastern side (fig.1) and resumes its course at the southern end of Tully Lake. All of these lakes and ponds are connected to the surficial aquifer, but their water levels fluctuate individually, depending on the degree of hydraulic connection with the aquifer.

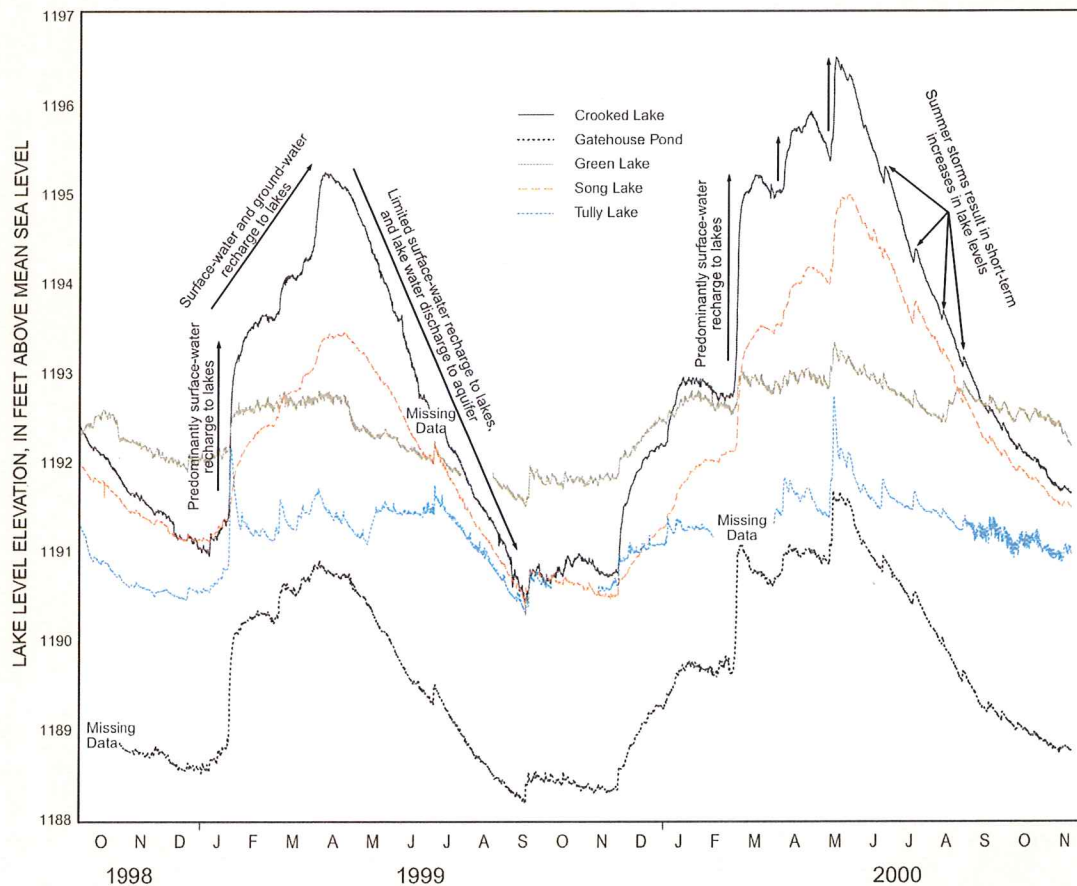
Figure 2. Water-surface fluctuations in five Tully Lakes, October 1998 through November 2000. (Locations are shown in fig. 1.)

Water levels in all Tully Lakes are controlled by the amount of precipitation, recharge from upland sources, surface-water runoff, rates of evaporation from the lake surface and transpiration by wetland plants, rates of ground-water seepage into and out of the lakes, and elevation of outflow channels, if present. Average annual water-level fluctuations in the western lakes during the study ranged from as small as 2.5 feet in Gatehouse Pond to as large as 6 feet in Crooked Lake (fig. 2). Water-level fluctuations in the eastern lakes were much less—about 1.5 feet.)

Runoff from the hillsides along the west side of the Tioughnioga Valley can quickly recharge the three western lakes through surface-water flow (Gatehouse Pond and Crooked and Song Lakes) during winter snowmelt and early spring rain periods and cause lake levels to rise as much as 2 feet within 4 to 5 days (fig. 2). Before and after these sharp rises, the lake levels generally rise slowly when recharge consists only of ground-water seepage along the west sides of these lakes. Recharge to these lakes exceeds discharge from them during the late winter and early spring and results in rising lake levels; whereas recharge during the summer is greatly diminished by high rates of evapotranspiration by wetland plants, evapotranspiration from trees on the forested hillsides, and limited water storage in the thin hillside soils.

Water levels in the eastern lakes decline during the summer, when the rate of discharge exceeds the rate of recharge, mostly through lake-surface evaporation and by transpiration of wetland plants. Heavy rainstorms during the summer that produce short-term, storm-water runoff from the uplands can cause small rises in lake levels (fig. 2).

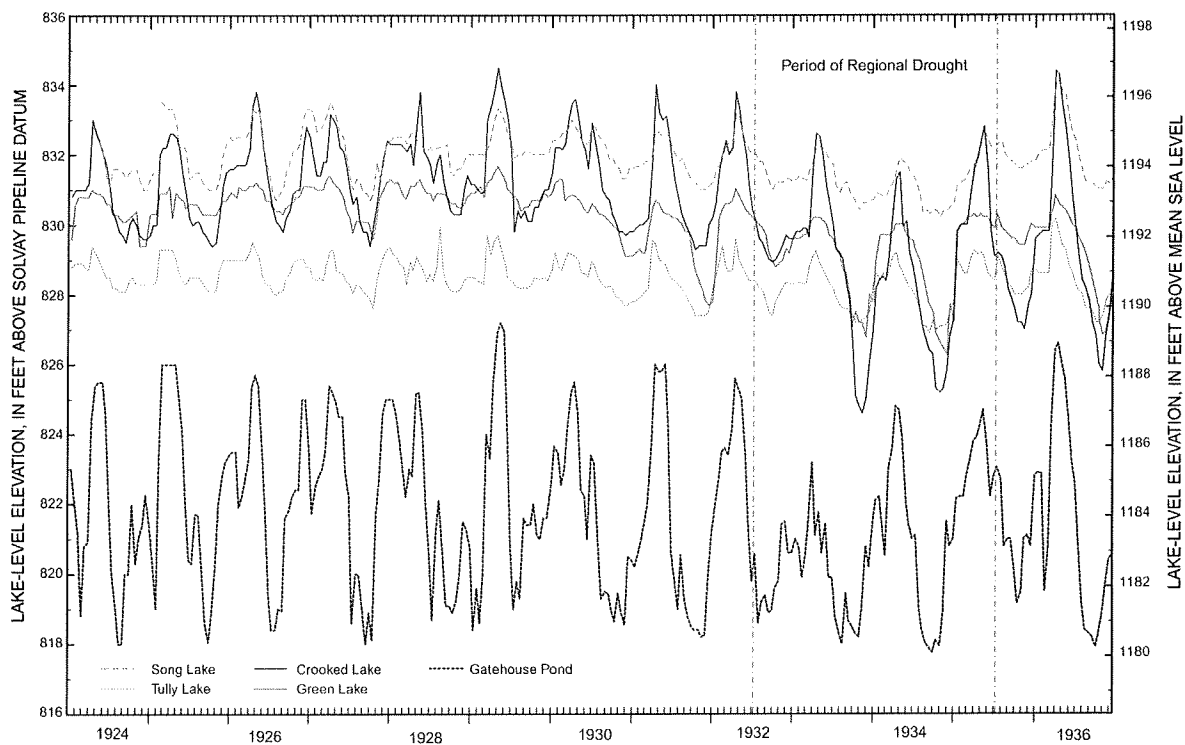
Figure 3. Lake-level fluctuations in five of the Tully Lakes, 1924-36. Water from Gatehouse Pond and Crooked Lake was diverted to the Tully brinefield during this period; the other three lakes had no diversions. (Data from the Solvay Process Company records, 1924-36.)

Water-level fluctuations in the Tully Lakes area were recorded by a mining company beginning in the late 1800's. The company used water from Crooked Lake, Gatehouse Pond, and intervening ponds for solution mining of halite (salt) beds in Tully Valley. Water levels in these lakes, as well as those in Song, Green, and Tully Lakes, which were not diverted, are plotted in figure 3. During the drought period of 1933-35, water levels in the lakes with diversions continued to follow trends seen in Green and Tully Lakes, which had no diversions. Therefore, the water levels in lakes probably were controlled by water levels in the surrounding aquifer, but the effects of diversion were most clearly seen in Gatehouse Pond, which supplied water to the Tully Valley. Gatehouse Pond is closest to the northern edge of the moraine, where aquifer levels were probably below the pond

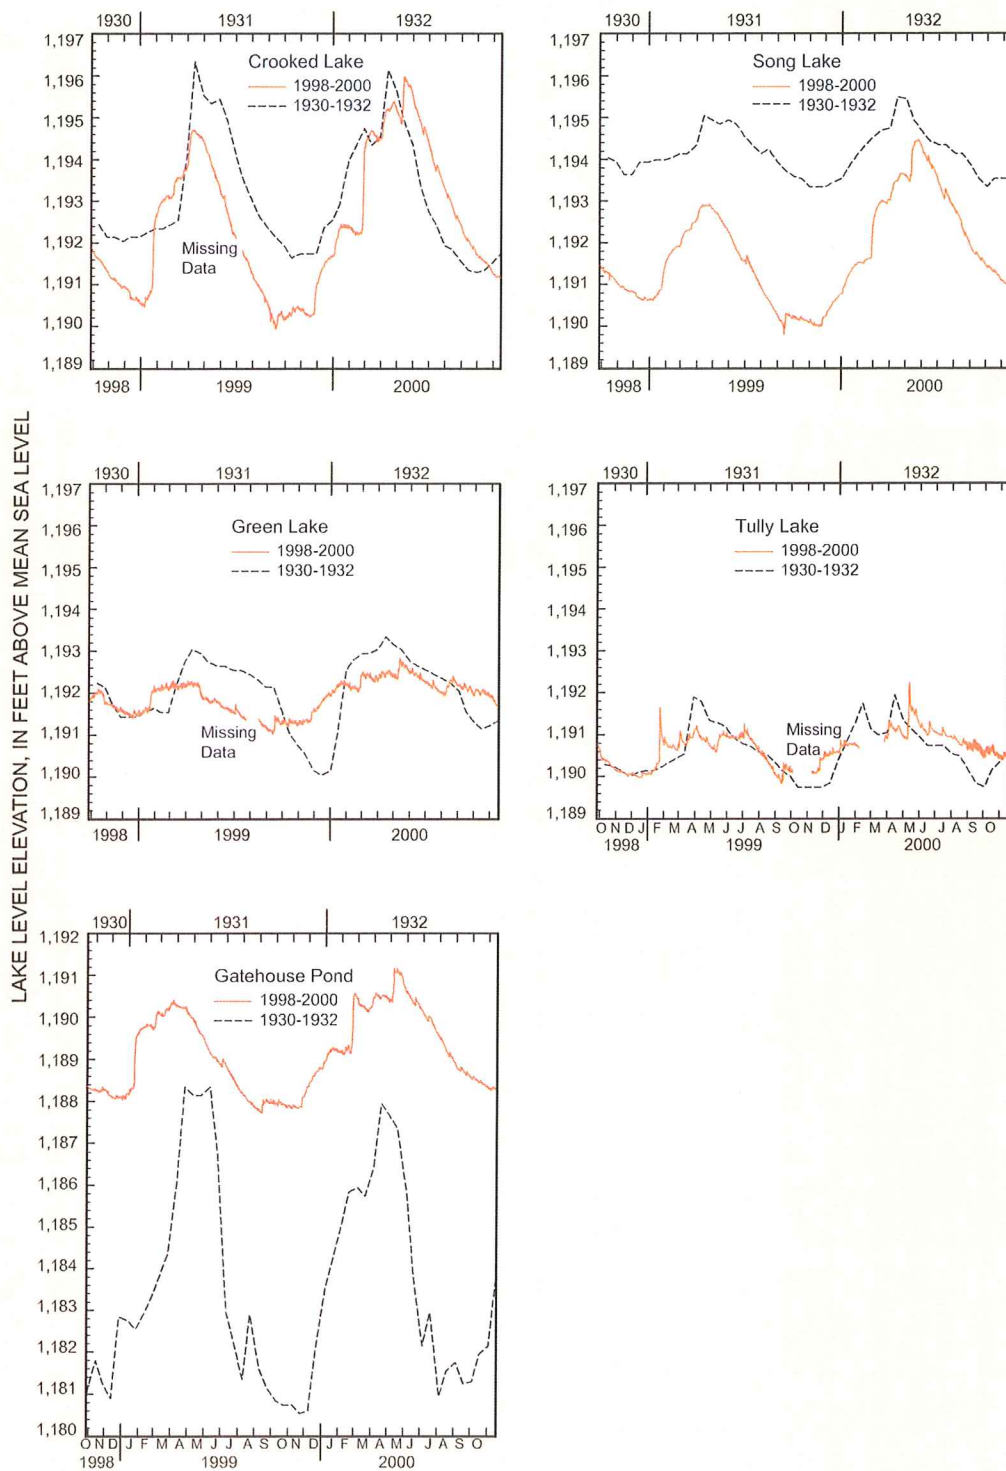
Figure 4. Lake-level fluctuations during 1930-32 during diversion of water from Gatehouse and Crooked Lakes to the Tully Valley, and during 1998-2000, when no diversions were occurring. (1930-32 data from Solvay Process Company.)

Lake-level fluctuations from October 1930 through November 1932 and from October 1998 through November 2000 are depicted in figure 4. Water levels in Gatehouse Pond were strongly affected by the diversion of water to the brinefield during the earlier period. The water-level fluctuations in Crooked, Green, and Tully Lakes were similar during both periods, even though some water from Crooked Lake was diverted for brine mining. The reason(s) for higher annual water levels in Song Lake during the 1930's than during the late 1990's is uncertain—it could be attributed to a less forested western hillside in the 1930's, which may have allowed greater recharge from the hillside to the lake through the summer, or, possibly, it could be due to an incorrect elevation datum for the 1930's lake level.

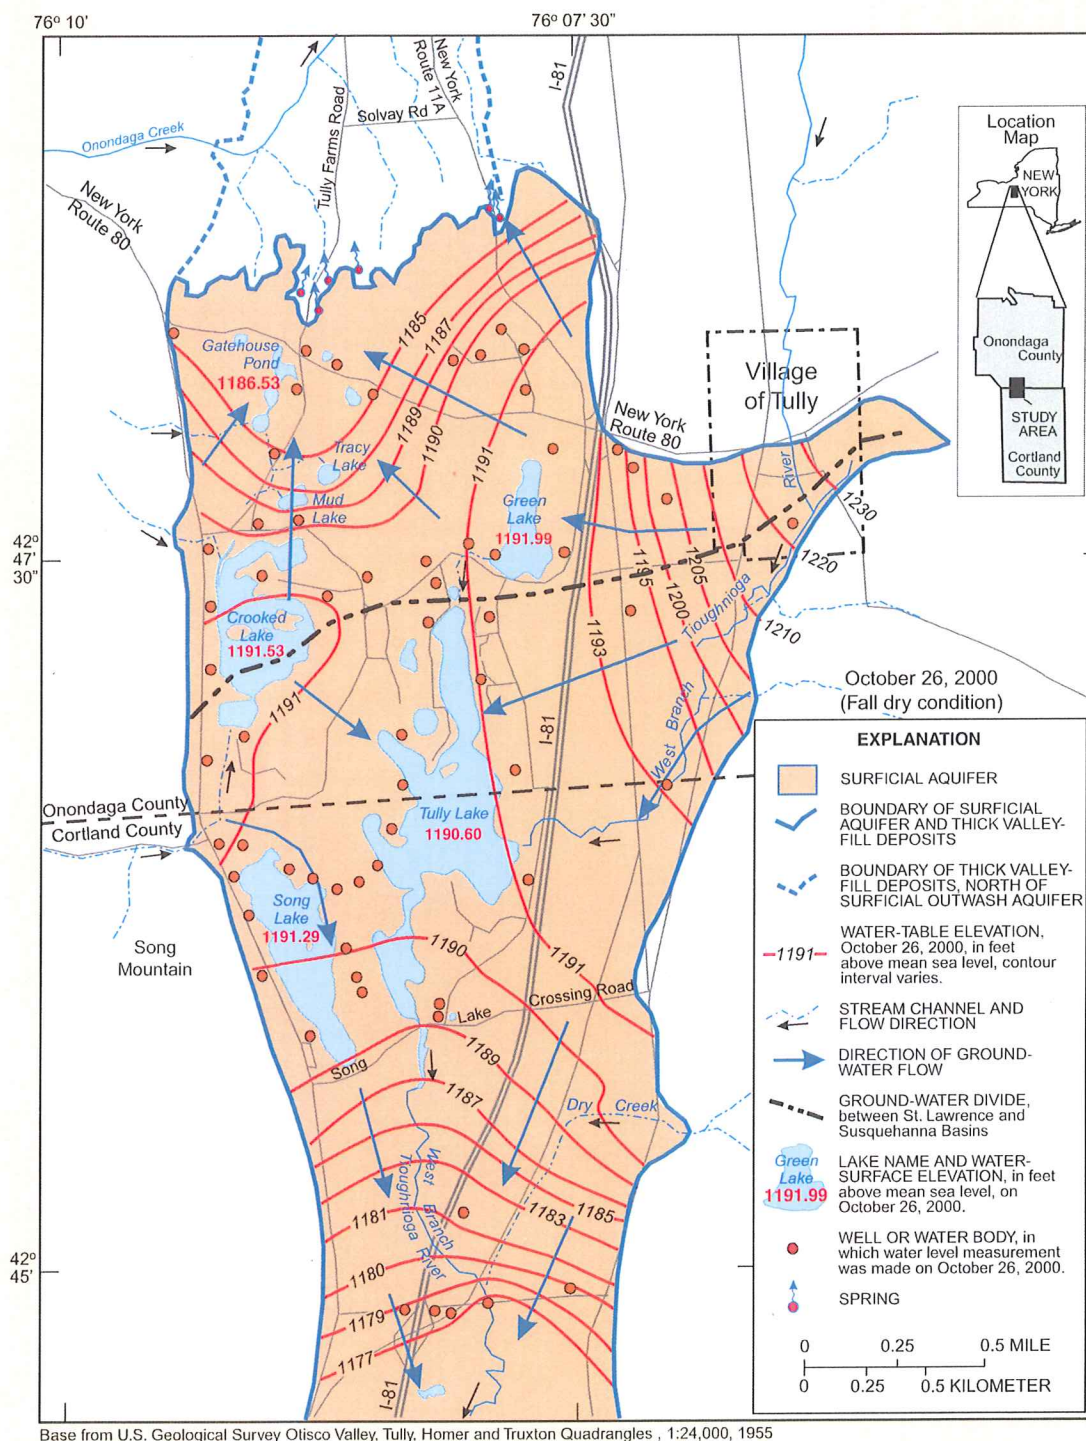
Figure 5B. Potentiometric-surface map of Tully Lakes area during fall dry period (October 26, 2000) showing water-table elevations, directions of ground-water flow, and location of ground-water divide between St. Lawrence and Susquehanna River Basins.

Potentiometric-surface (ground-water elevation) maps for April 26 (spring recharge period) and October 26 (fall dry period), 2000, were constructed (figs. 5A, 5B). The potentiometric-surface contours indicate that the major ground-water divide trends roughly west-east about 1 mile south of the crest of the moraine and migrates southward during the summer as ground-water levels decline. The water-level declines from April through October 2000 ranged from 1.5 to 8.0 feet.

Ground water flows from areas of higher head to areas of lower head and, in the Tully Lakes area, is controlled by the distribution of recharge, locations of discharge areas, and the geometry of the aquifer. Ground water generally flows from the edges of the valley toward the center, where it discharges to lakes, ponds, wetlands, springs, and the West Branch Tioughnioga River (figs. 5A and 5B).

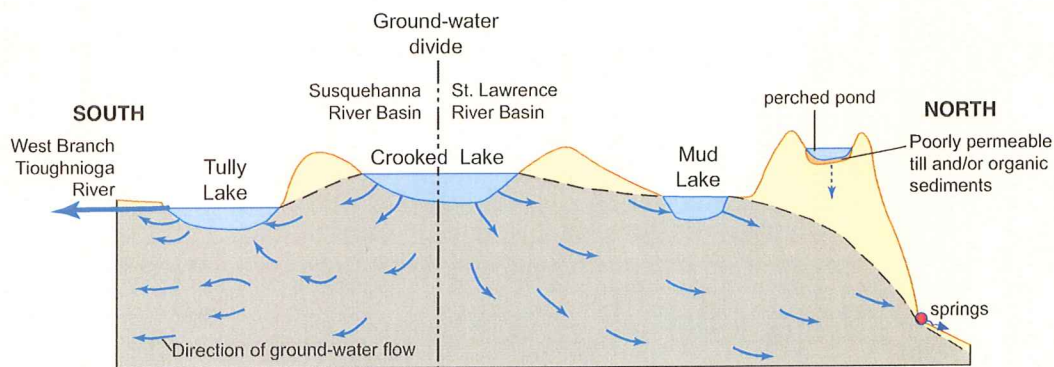
Conceptual ground-water flow system for the Tully Lakes area, showing the interaction of kettle-hole lakes and the surficial aquifer.

Kettlehole lakes and wetlands underlain by highly permeable deposits can receive ground-water seepage on one side and discharge ground water on the other side. The boundary between inflow to the lake or wetland and outflow from it, termed the hinge line, can move up and down along the shore (Winter and others, 1998) depending on the changing slope of the water table in response to fluctuations in ground-water recharge in the adjacent uplands.
